Seismic Assessment of Repaired Bridges in Chile

ABSTRACT

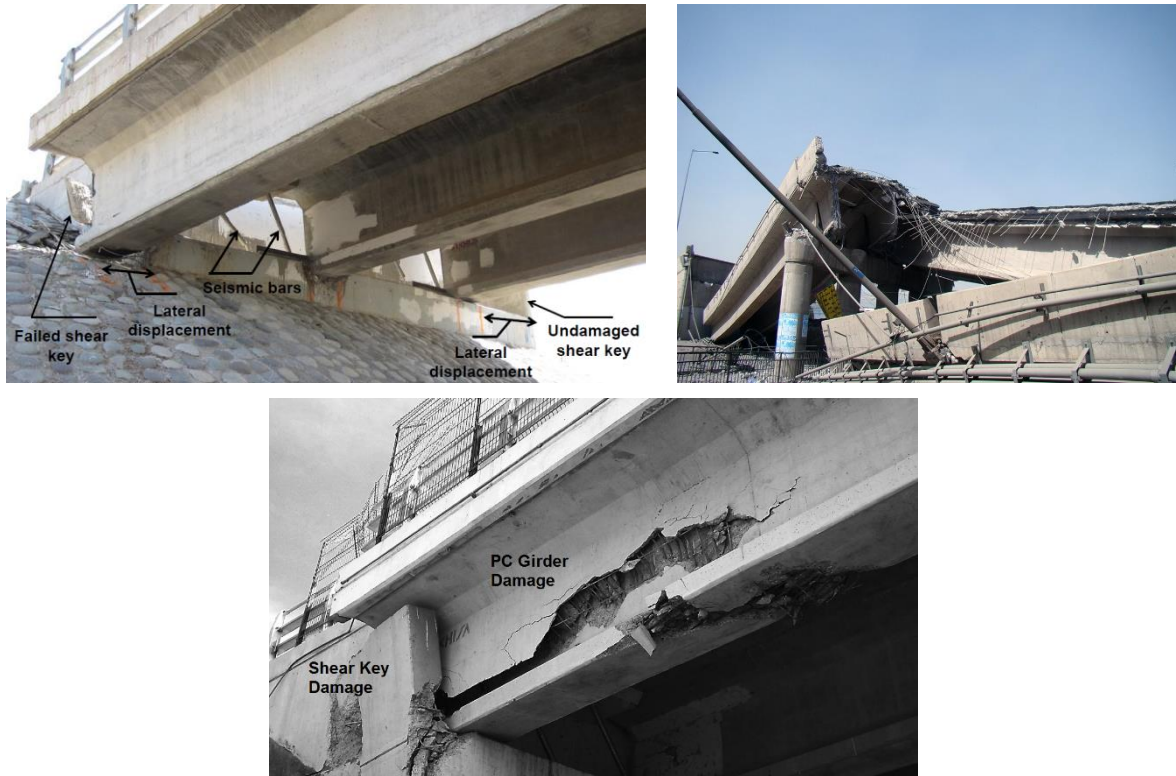
which is characterized by excessive displacements between the superstructure and the substructure as shown in Fig. 1, was caused by a lack of effective unseating-prevention devices, lack of transverse diaphragms and short superstructure seat-length on bents and abutments allowed by the seismic design criteria used at that time (MOP, 2002).

Fig. 1 Damage observed in highway bridges after the 2010 Maule earthquake. (Photos: M. Yashinsky, J.L. Seguel, F. Schanack)

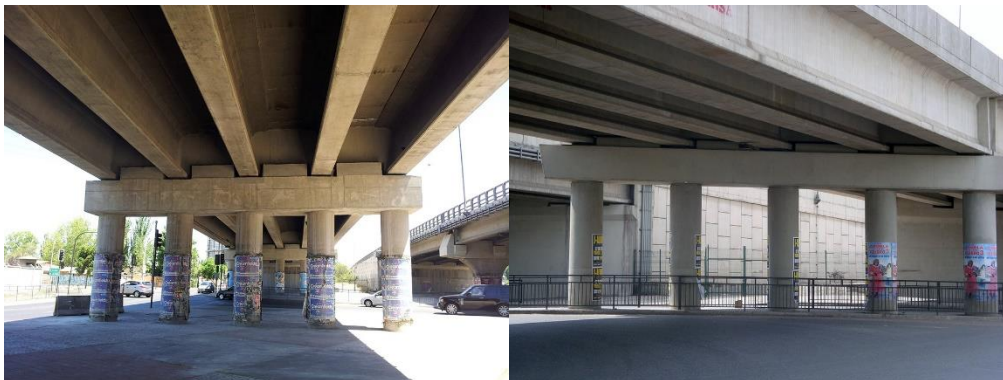
Fig. 2 Repaired/Retrofitted Bridges. (Photos: J.L. Seguel)

After the earthquake, it was evident that the seismic performance of highway bridges in Chile was deficient. As a consequence, bridges were primarily repaired and retrofitted using reinforced concrete stoppers (shear keys) and increasing the seat-length at the supports (abutment and bents) as shown in Fig. 2.

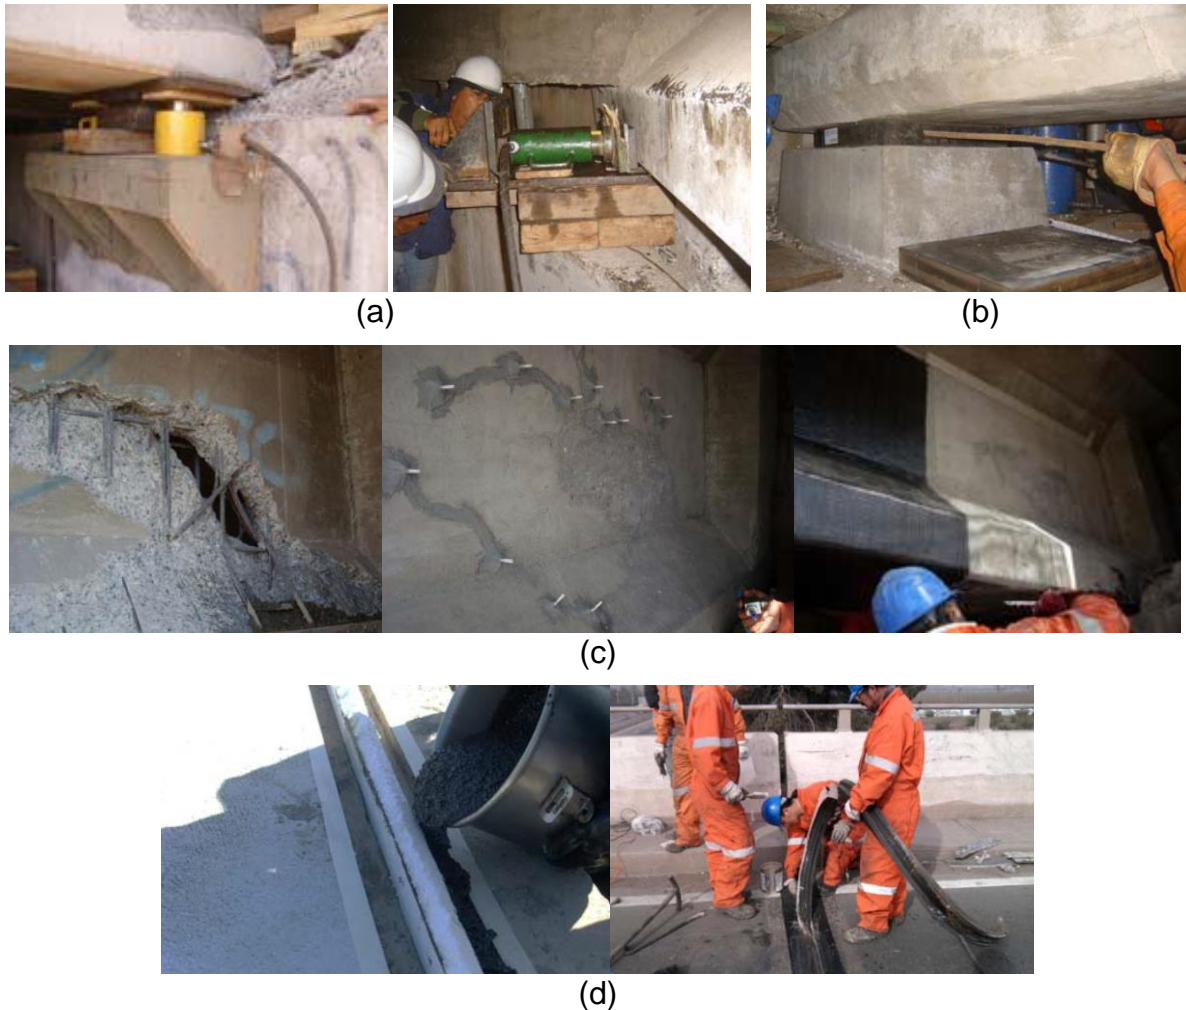
Fig. 5 Procedures to repair and retrofit damaged bridges after the 2010 Chile Earthquake. (Photos: D. Ortiz-TECNOAV)

- 1) restituting the deck to its original position by using vertical and horizontal hydraulic jacks (Fig. 5a). This procedure also allowed replacing the damaged elastomeric bearings for new ones (Fig. 5b)

- 2) repairing the damage in PC girders by removing all the loose concrete and damaged bars to then applying a bonding agent in conjunction with repairing mortar with fiber. In some cases, cracks were injected with special epoxy and girders were retrofitted using carbon fiber reinforced polymer (CFRP) as shown in Fig. 5c.

- 3) replacing expansion joints (Fig. 5d), and adding transverse diaphragms, seismic bars and shear keys.

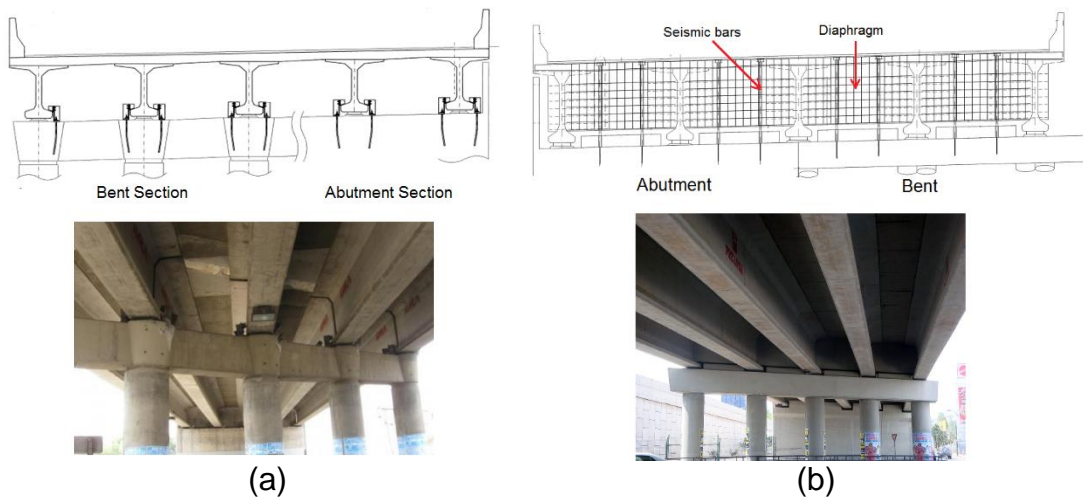
Fig. 7 Lo Echevers overpass (a) original bridge, (b) repaired/retrofitted bridge

After the 2010 earthquake, the structure was repaired by replacing the deck for a new one, increasing the cross-section of the cap beam, replacing lateral steel stoppers, which had deficient seismic performance during the earthquake, for massive reinforced concrete shear keys, increasing the dimensions of elastomeric bearings, and

including vertical seismic bars and transverse diaphragms at bents and abutments. The original and repaired bridge are illustrated in Fig. 7.

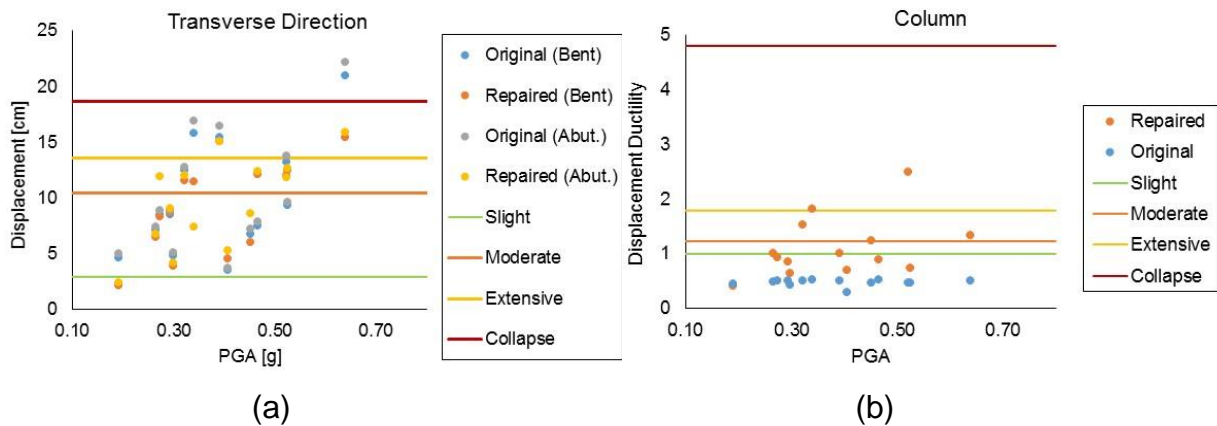
The damage states for the multi-column bent and elastomeric bearings using the unscaled ground motions are shown in Fig. 15. The resulting displacements for the elastomeric bearings (Fig. 15a) were recorded at the abutments and bents. These results show that the repair measures were effective in reducing the displacement demands in the elastomeric bearings. Moreover, a direct relation can be observed between the peak ground acceleration and the displacement demand in the bearings.

It is important to mention that in the original condition 100% of the displacement demands exceeded the slight, 50% the moderate, 20% the extensive and 4% the collapse damage states, while in the repaired condition 95 % exceeded the slight damage state and none of the records cause the bearings to collapse.

Regarding the damage states in the columns, it can be observed that in the original condition none of the demands exceeded the slight damage state, which indicates that the columns did not reach yielding. This result was also concluded from

the capacity curves. For the repaired condition, on the contrary, 50 % of the ground motions caused column yielding and two records caused extensive damage.

Fig. 15 Damage states using unscaled records. (a) Elastomeric bearings, (b) Columns

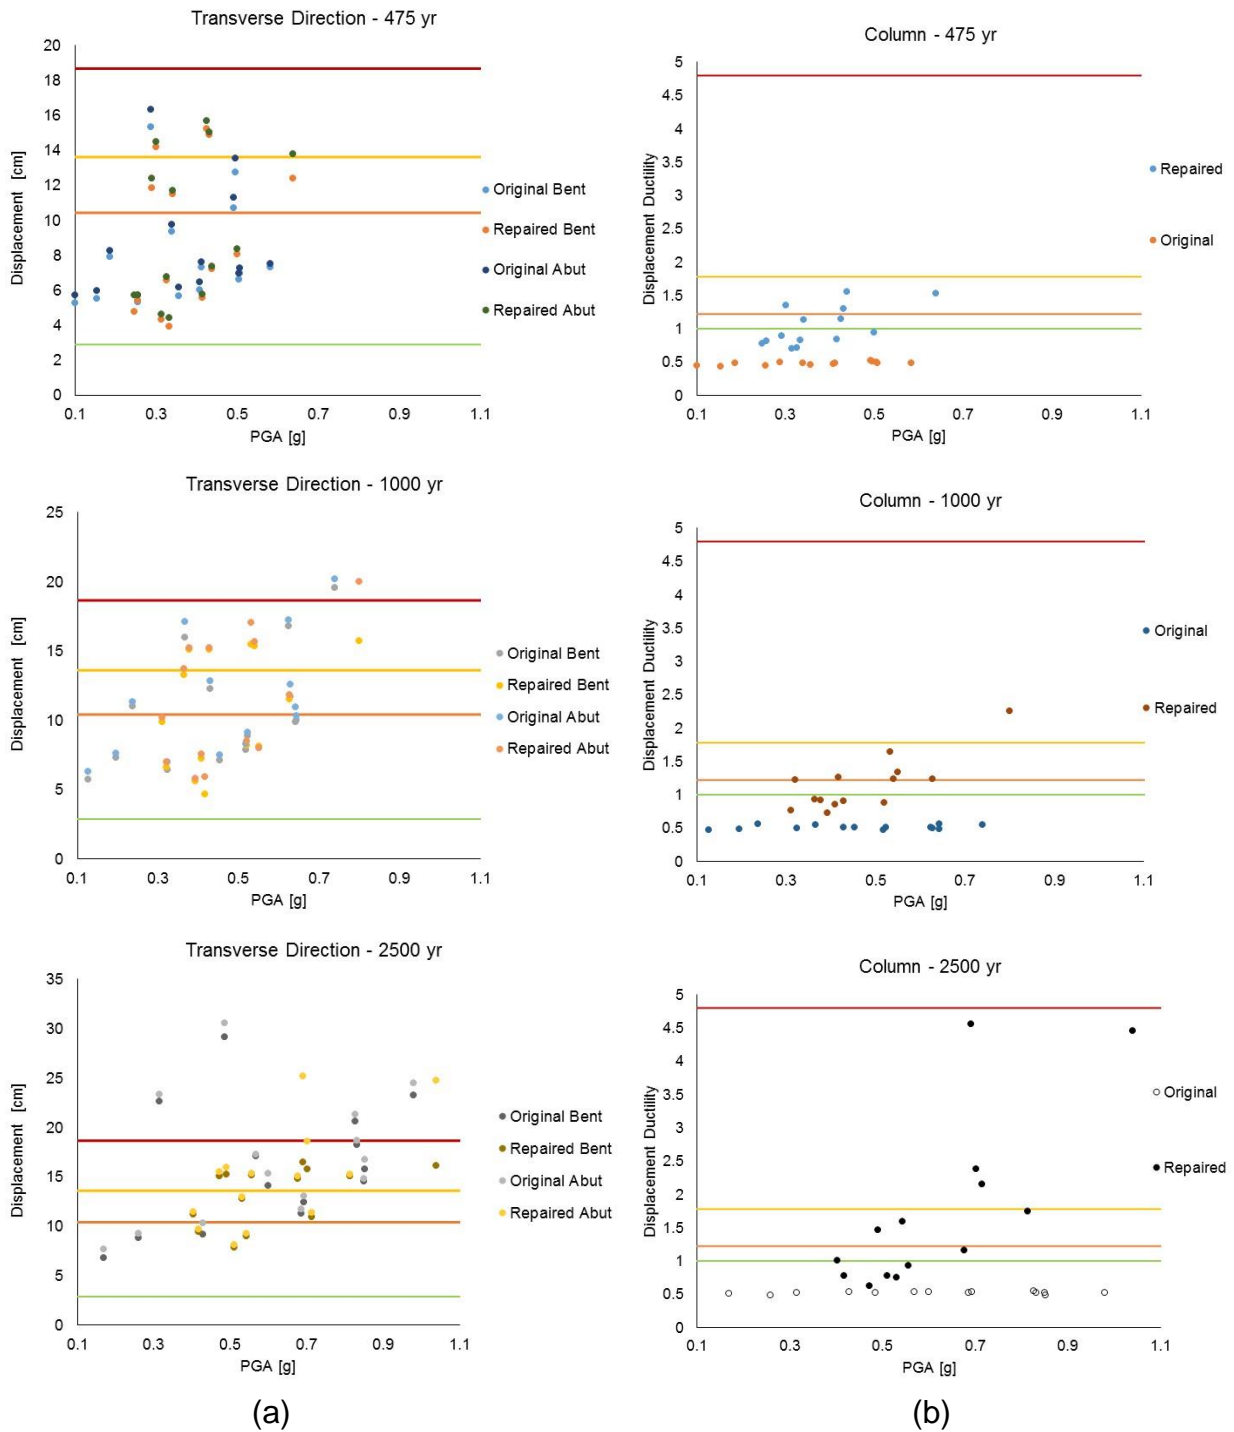
In terms of damage states, it can be observed from Fig. 16 that all the ground motions caused slight damage in the bearings and as expected the damage in the bridge get more severe as the seismic hazard increase. This result becomes clear when the displacement demands obtained for the 475 and 2500 yr hazard levels are compared. While for the 475 yr hazard none of the ground motion exceeded the collapse damage state, 10 ground motions exceeded it for the 2500 yr hazard. It is important to note that even though the repair measures limit the displacements and improve the performance of the superstructure (elastomeric bearings), collapse damage state can still be reached for a severe ground motion (2500 yr event).

Regarding the damage states in the columns, similar conclusions to previous sections can be mentioned, i.e. in the original bridge none of the ground motions can cause column yielding since the forces transferred from the superstructure to the substructure are not enough to cause such state. On the contrary, in the repaired bridge many of the considered ground motions can demand the columns above its yielding and in cases of severe ground motions (2500 yr event), the columns may even be closed to reaching the collapse damage state. Again, this result raises a red flag about the importance of designing a ductile substructure where seismic bars and strong shear keys are used.

Fig. 16 Damage states using amplitude scaling. (a) Elastomeric bearings, (b) Columns
