Slope Stability Analysis of Granitic Residual Soil Using SLOPE/W, Resistivity and Seismic

1), 2), 3), 4), 5), 6) *Institute Of Energy Infrastructure, Universiti Tenaga Nasional, 4300
Kajang, Malaysia*

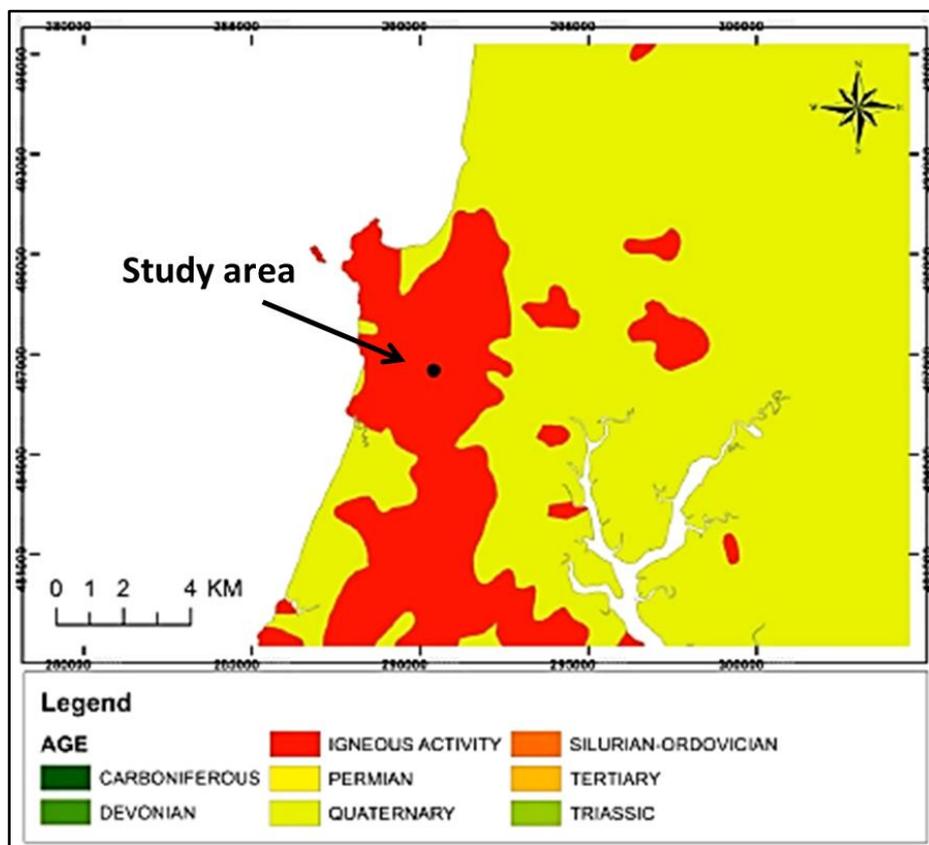
Fig.1 Geological map of study area

The study area is located in Perak which is indicated in Figure 1. The geology of study area is dominated by igneous activity consisting of granitic rocks that include quartz, feldspar and mica, but due to weathering, the strength of granite is reduced. The site is underlain by intrusive rocks, mainly Biotite Granite which is composed of fine, medium and coarse-grained granites. This intrusive rock is part of Dinding's pluton in

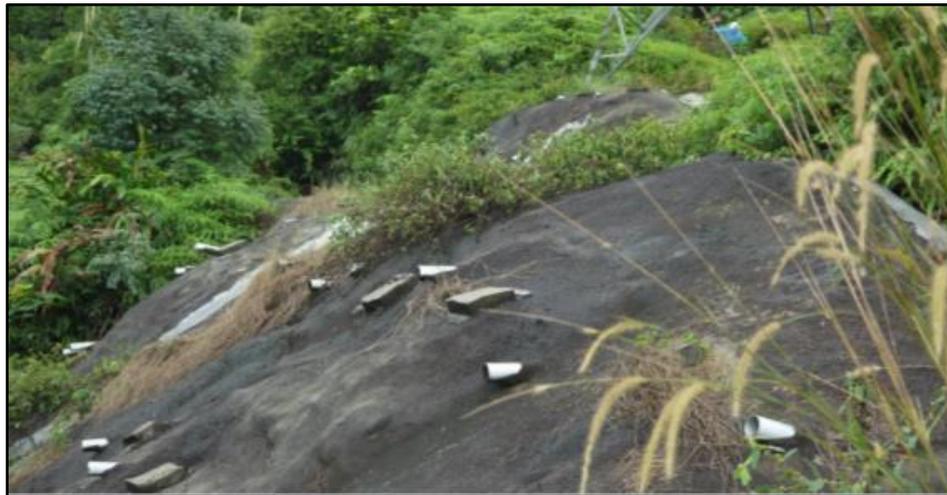
Fig. 2 Treated slope using grouted nails and cement grouting

Main Range granitoid province. Radiometric dating shows that this rock age was 213 Megaannum (Ma). Most of the granites that were exposed in this area have undergone weathering process. The exposed rock is made up of Weathered Granite Grade IV to VI. The geophysics survey including resistivity and seismic study was conducted along the line located at 4°23'37.4" N latitude and 101°36'13.6" E longitude on the slope to obtain the subsurface information. Table 1 showed the coordinates of the survey line. A slope failure has occurred two years ago due to heavy rainfall and landslide. After the incident, slope rehabilitation was implemented by constructing retaining wall using soil nailing method and cement grouting to reinforce the slope since the method was effective and economical (Qasim, S., 2016). Figure 2 showed the treated slope using soil nailing method.

0.186 which is less than 1.0 indicating the instability of the slope condition. The actual slope circle failure has already taken place at the study site and the soil nailing was installed to prevent further slope failure. Constant monitoring should be carried out on existing slope (Stähli, M., 2015). The study area was also experiencing soil erosion on the surface due to the existence of small gully that has developed previously. Therefore, erosion control measures should be carried out to prevent or reduce movement of eroded soil sediments off-site or land. The controls often involve the creation of a physical barrier, such as vegetation cover or rock, to absorb some of the energy of water that is causing the erosion.

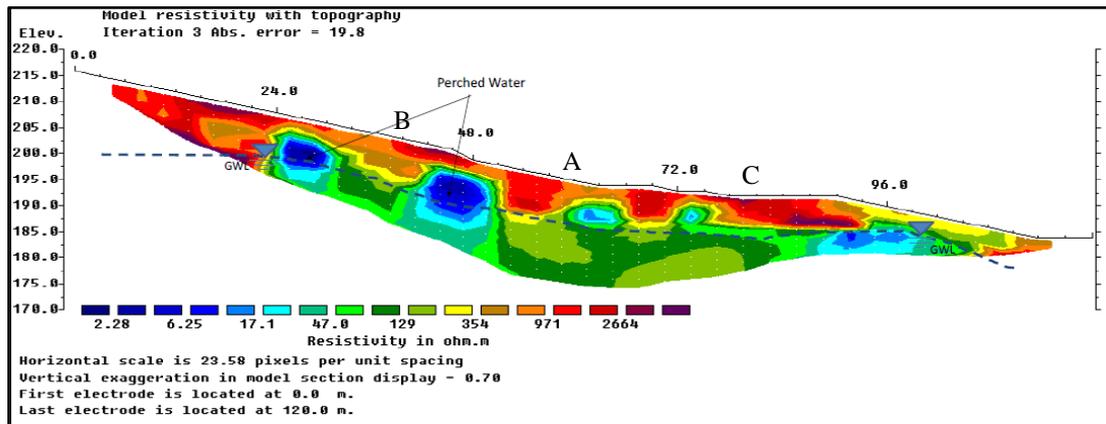
Fig.3 2D Resistivity model of study area

Based on resistivity survey, the existence of groundwater level has been found at a depth of 10.0 m from ground level. Generally, the subsurface is made up of sandy soil from weathered granite which range of resistivity value from 351 Ohm-m to 2670 Ohm-m. The stiff to very stiff layers of Sandy CLAY were interpreted 10.0 m below the surface around the tower with range of resistivity value 41 Ohm-m to 130 Ohm-m. The Standard Penetration Test (SPT-N) and Rock Quality Designation (RQD) for soil and rock types in Table 3 have been interpreted at 1.5 m depth from the surface level based on the depth of borehole. This area consists entirely of weathered rock with RQD values of 25% to 50%, only a quarter of the area with RQD values of 50% to 75%. The stiff to very stiff soils were discovered at 10.0 m depth with SPT-N values 9 to 26. There are also soils that are classified as very soft to soft due to existence of perched water.

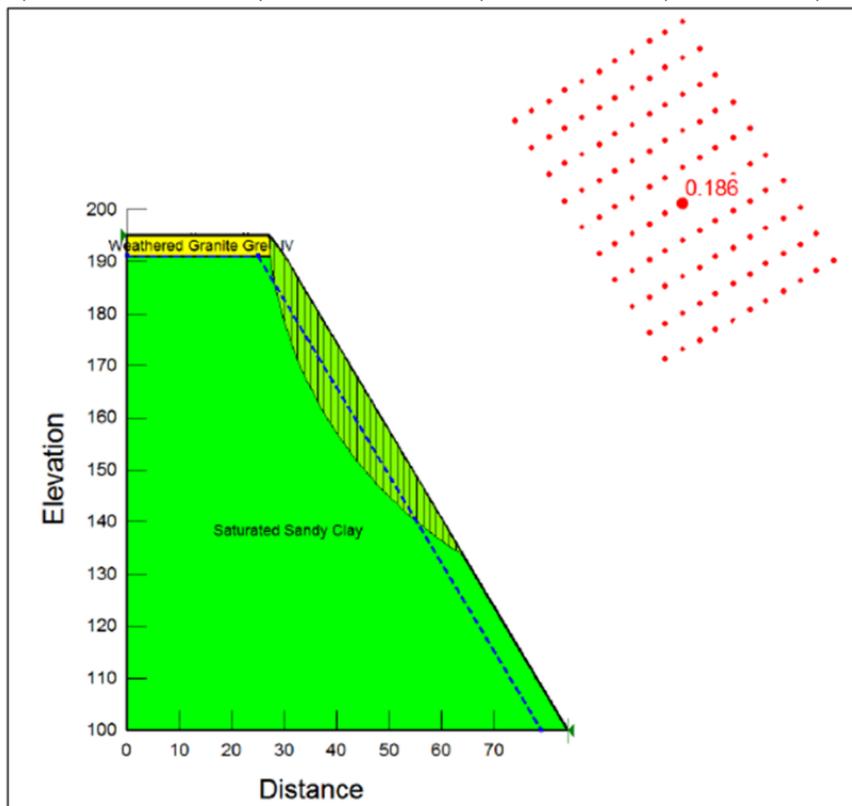
Fig. 4 FOS model of study area.

SLOPE/W analysis was processed based on geophysics analysis; resistivity and seismic as well as laboratory testing. From this analysis, the slope was predicted to be unstable based on FOS value which was 0.186 according to the guideline of slope stability. Table 6 shows the parameters of SLOPE/W analysis that generates FOS as shown in Figure 4.
