Emergency Measures for Vortex-induced Vibration of Humen Bridge

ABSTRACT

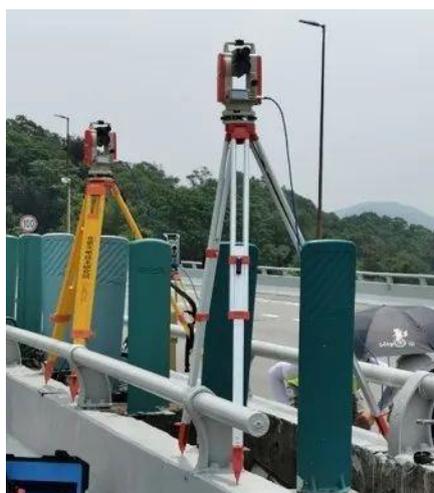
Video imaging displacement-measured sensor (Fig.3) and portable anemometer were used to observe the displacement response of Humen Bridge and the wind environment of the bridge deck. And the detailed dimensions of the bridge deck, especial railing and the collision wall, were measured on the spot. Meanwhile, the all-weather multi-purpose mobile meteorology monitoring vehicle (mobile laboratory for on-site investigation and testing of wind effects, for short as "wind-chasing vehicle") of Tongji University was also used, shown in Fig.4.

Fig.3 Displacement measurement by video imaging technique
