Tilting table tests on strengthened masonry houses

*Ahmet Turer¹⁾ Mustafa Golalmis²⁾ H. Husnu Korkmaz³⁾ and
Serra Zerrin Korkmaz³⁾

¹⁾ Middle East technical University, Civil Engineering Dept. Ankara-Turkey.

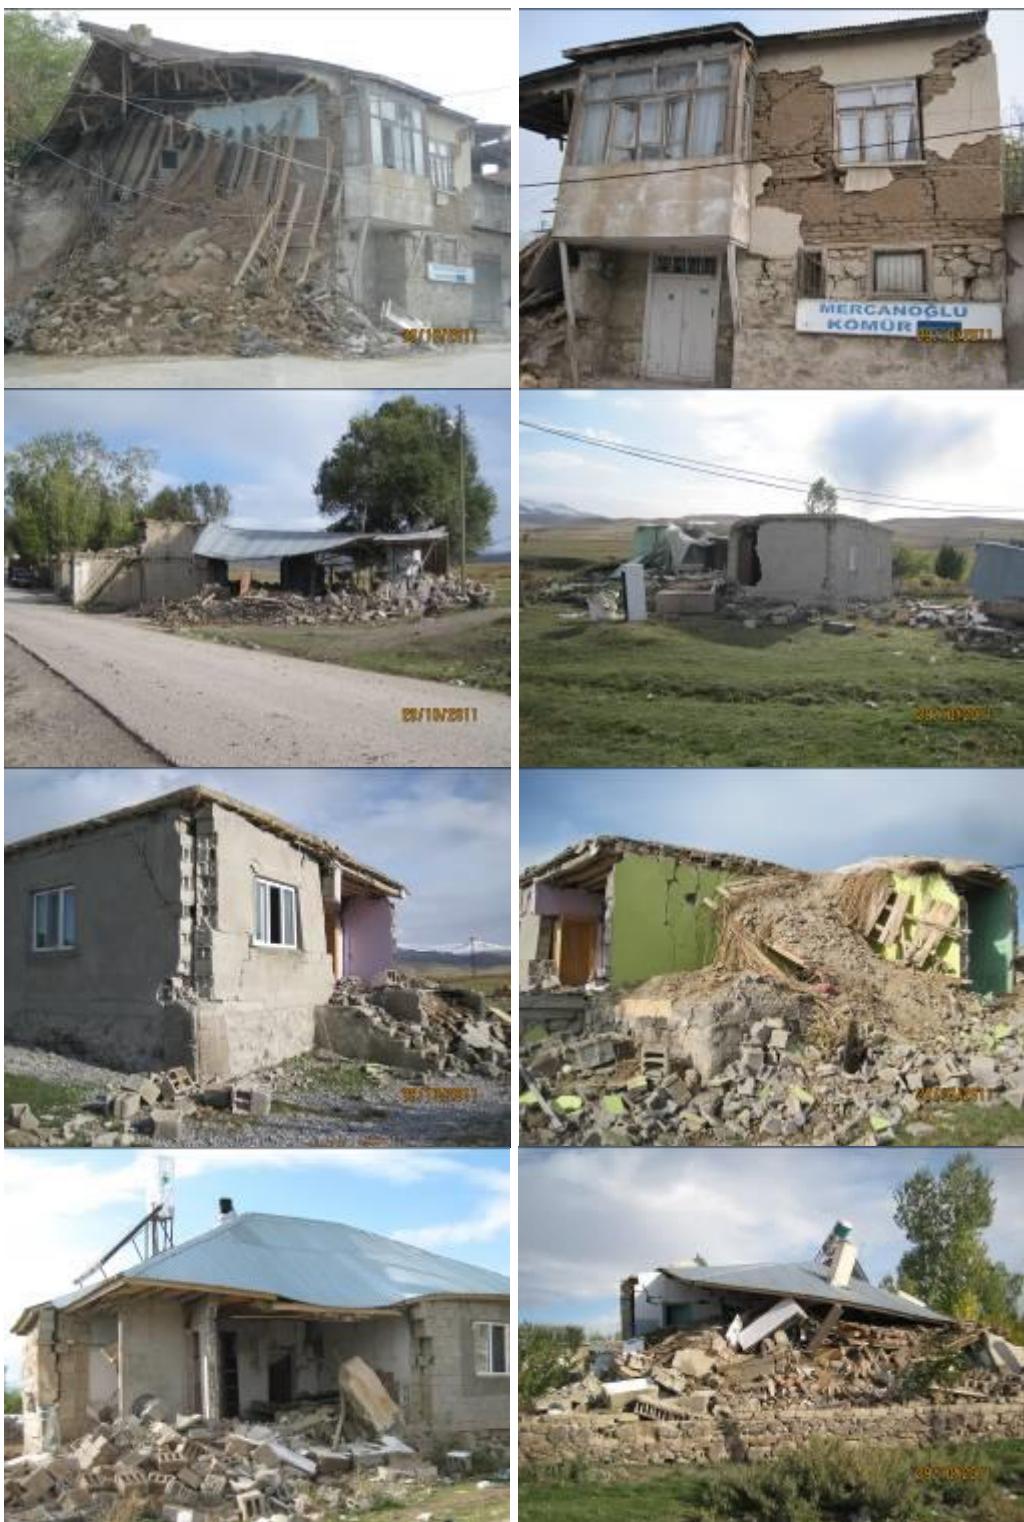
Fig. 1 Common modes of failure of rural masonry structures
(Pictures from Van Earthquake -2011-Turkey, Source: Korkmaz S. Z.)

Developing countries, that have active faults, also commonly have poor population living in self-constructed masonry houses. The poor economic and social background of the residents also means that masonry constructions do not receive any engineering services and, therefore, are susceptible to heavy damage or total collapse during earthquakes. Masonry houses are composed of building blocks with weak inter-binding action which have low tension capacity. The corner connection of the walls experiences higher stresses during earthquake action. At ground motion, all the structure is set in motion and different parts of the structure attempt to vibrate with different characteristics. The stiff structural system of the load-bearing walls and roof and the flexible characteristics of the non-load-bearing walls vibrate in perpendicular directions and the corners of the walls, being the junction between them are the areas of highest stress. Corner separations are the most observed type of failures after earthquakes. Once the corners have failed, the adjacent walls are more likely to fail out-of-plane and overturn. The disintegration of masonry constructions built from adobe, brick, or stone is very quick and it leads to a total collapse of the roof which is traditionally composed of very heavy earth (Fig. 1).

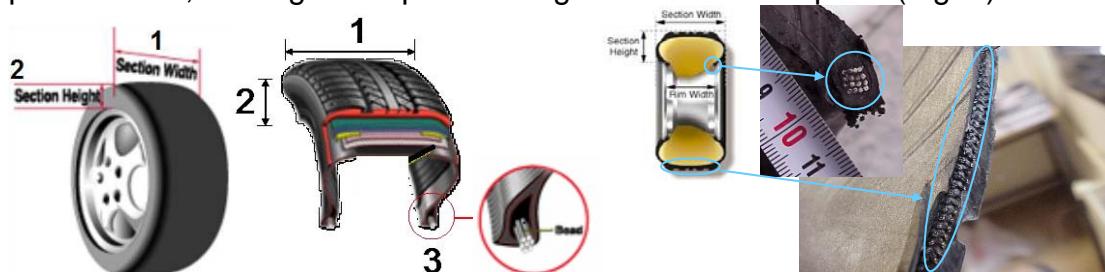
Fig. 2 Section of tire

In the target strengthening scheme, the main material used is scrap tires, which are available almost at no cost. Tire is formed from four main parts which are tread, shoulder, sidewall and bead (Turer 2005). The tread contains a number of strong cords coated with rubber. The high-tensile steel wires are embedded in the tread and bead parts of tires, making these parts stronger than the other parts (Fig. 2).

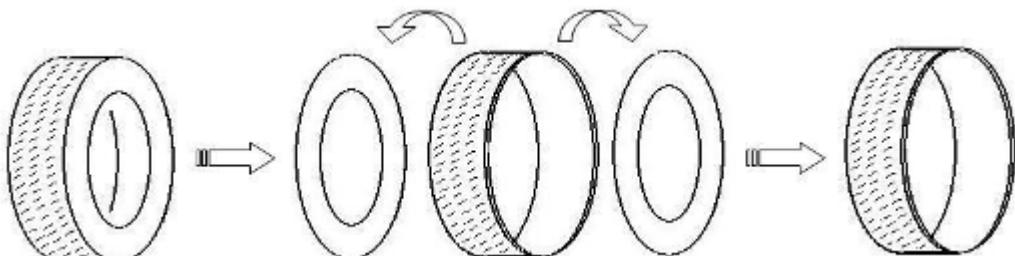
Fig. 3 Obtaining scrap tire rings (Korkmaz 2006 and Turer 2007)

In this study, only tread (sidewalls removed) are used. Therefore, firstly, the tensile strength capacities of these parts were investigated. Two sidewalls of scrap tires are cut out using a sharp utility knife and ring-shaped section of a tire "Scrap Tire Ring-STR" is obtained (Fig. 3).

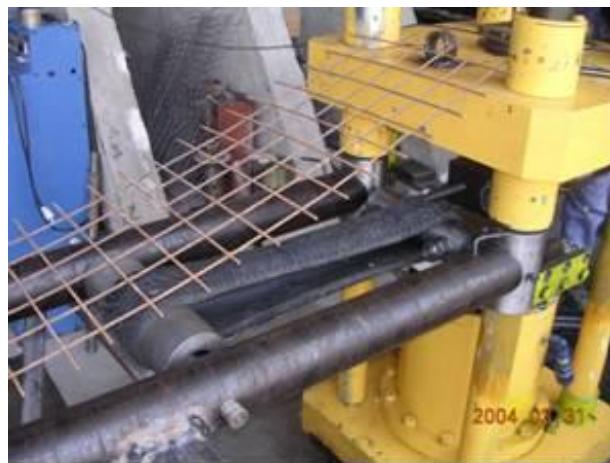
Fig. 4 Single-STR test set-up (Turer 2005)

Turer 2008 and Golalmis 2005 conducted a series of tests to measure tensile strengths and load-deflection behavior of Scrap Tire Rings (STR). A test setup is designed and constructed in the laboratory (Fig. 4). The testing scrap tire parts was conducted directly pulling it apart. More than 40single-STRs, which belong to different trademarks are tested in direct tension. The minimum and maximum tensile strengths among the tested specimens are 90 kN and 190 kN, respectively. The shapes of the load-deflection curves are similar and show linear-like slopes after an initial load of about 50 kN is applied.

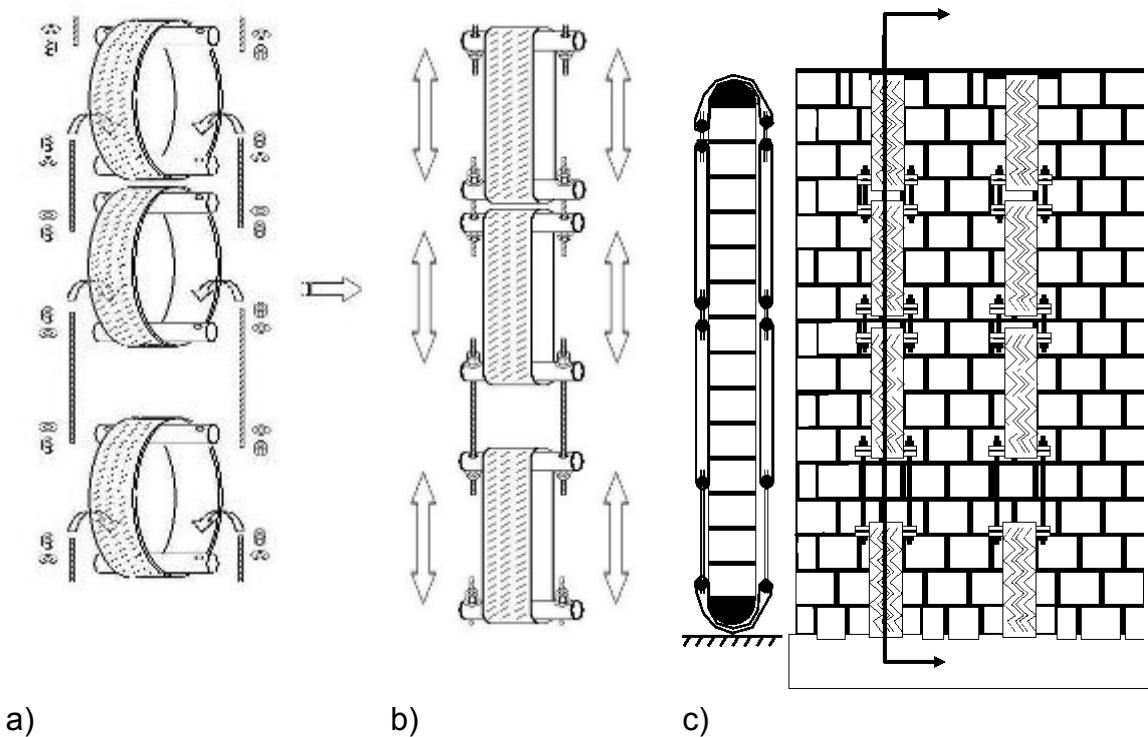
Fig. 5 Application of vertical strips (Korkmaz 2006)

Walls of masonry type houses are generally weak in out-of-plane bending direction (for forces induced during an earthquake) which can be improved by post-tensioning. The STRs are planned to be used for post-tensioning of masonry walls and the maximum tensile force foreseen to be used is about 25 kN to 50 kNs not exceeding capacity. The STR chains are wrapped around the masonry wall as shown in Fig. 5-a. By turning the bolts, the STRs are pulled together while adjustable tensile force is applied on the STR chains (Fig. 5-b). The scrap tire rings are passed through the holes opened at the bottom of the wall, just above the ground. On the top, it wrapped around the top roof girder. Semi-circular wooden logs are placed between the wall and STR chain (Fig. 5-c) in order to avoid stress concentrations on the wall application points and evenly distribute the post-tensioning forces on the wall.

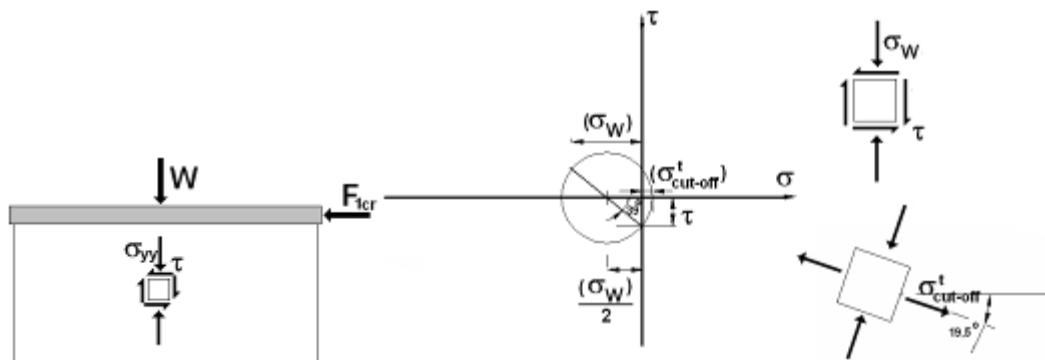
Fig. 6 Explanation of the failure mechanism with Mohr Circle (Turer and Korkmaz 2007)

Shear walls commonly fail in diagonal direction due to the formation of principle tensile stresses. Masonry walls loaded in their strong axis in shear show a similar failure pattern as the low tensile capacity is reached on a diagonal plane. The effect of post-tensioning on the shear capacity can be explained and illustrated using Mohr Circles as shown in Fig. 6. The horizontal in-plane load of F_{cr} generates shear stresses (τ). The failure of the wall is assumed to be governed by the tensile stress capacity of $\sigma_{cut-off}^t$, as shown in Fig. 7. The vertical load (W) is generated by the heavy dead load of the earth fill roof causing the vertical stress value of σ_w (Turer and Korkmaz 2007).

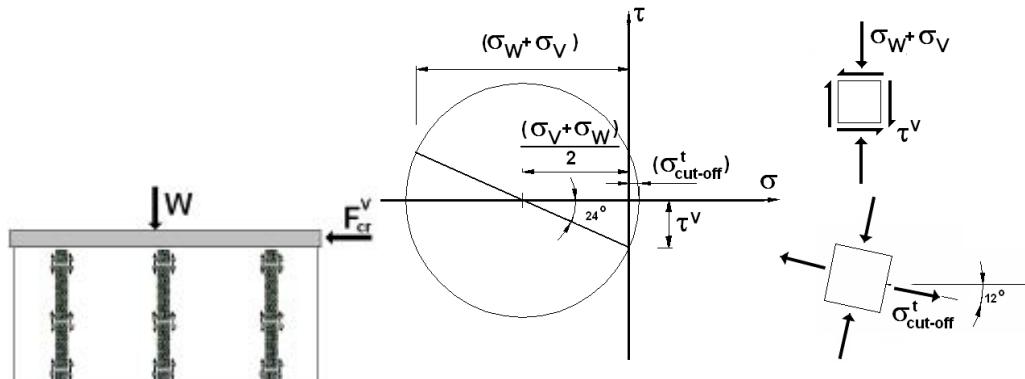
Fig. 7 Explanation of the capacity improvement under vertical wrapping (Korkmaz 2006)

The effect of vertical post-tensioning on shear load carrying capacity is simulated in Fig. 7 as additional vertical compressive stress (σ_v) is generated by the STR chains.

The centroid of the Mohr-Circle is shifted towards the compressive region of the stress axis by an amount of $\sigma_v/2$. Although the radius of the Mohr-Circle increases significantly, the useful shear capacity increase in τ_v remains low (Fig. 7) since the shear stress plane orientation for F_{cr}^V integration remains flat and refers to a relatively small τ_v value (Turer and Korkmaz 2007).

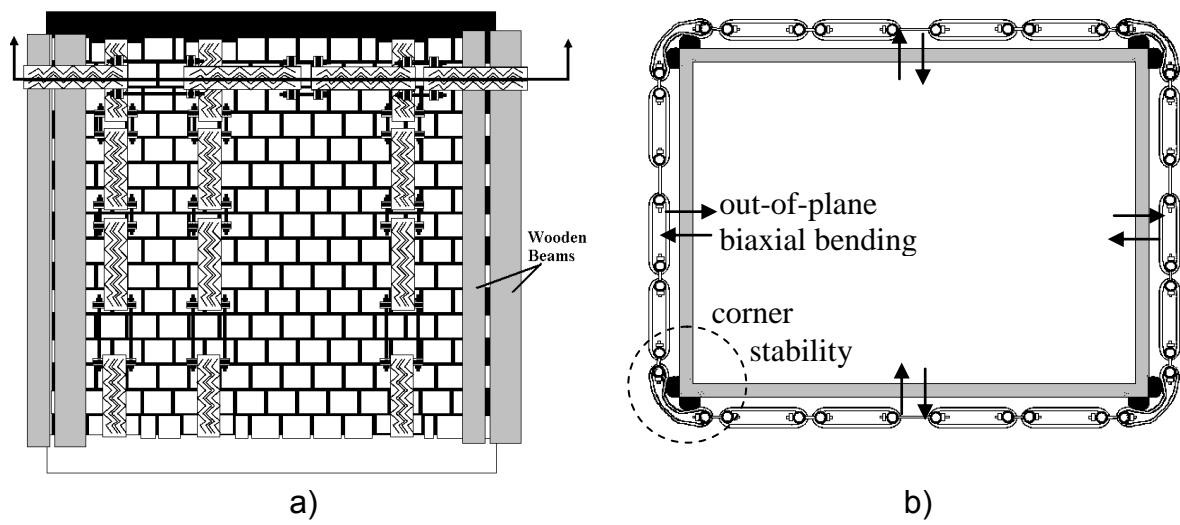
Fig. 8 Application of horizontal wrapping (Korkmaz 2006)

As explained before, corner separation is the most frequently observed failure characteristics of masonry houses. In order to supply confinement effect on the masonry structure it is proposed to wrap STR chains around the house in the horizontal direction. Eight semi-circular wooden beams are placed at four corners of the structure and STR chains are placed and stretched around the perimeter of the building (Fig. 8). The horizontal wrapping under the roof level is considered to supply additional confinement effect in transverse direction while keeping the corners together and delaying the corner connection separation of the walls. The transverse direction post-tensioning also increases the walls' out-of-plane bending capacity in a bidirectional effect.

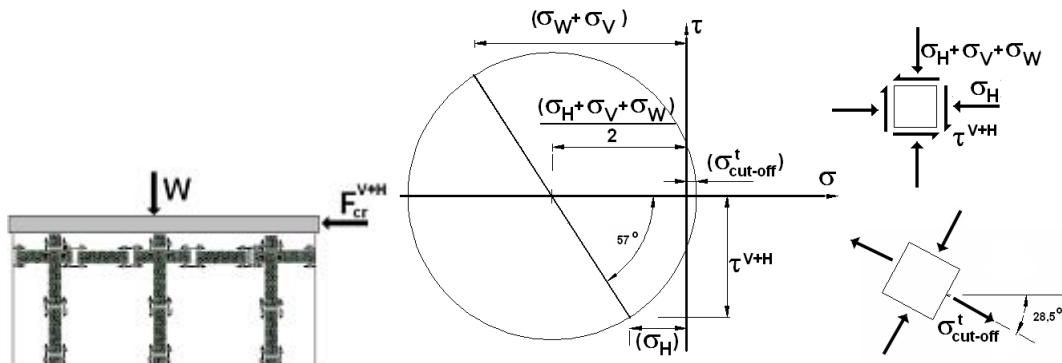
Fig. 9 Capacity improvements due to horizontal and vertical wrapping (Turer and Korkmaz 2007).

The most pronounced increase in shear load capacity (F_{cr}^{V+H}) is achieved when the wall is post-tensioned in vertical and horizontal directions (Fig. 9). The optimum performance would be obtained when horizontally applied stress (σ_H) is equal to the vertically applied total stress (σ_W or $\sigma_W + \sigma_V$).

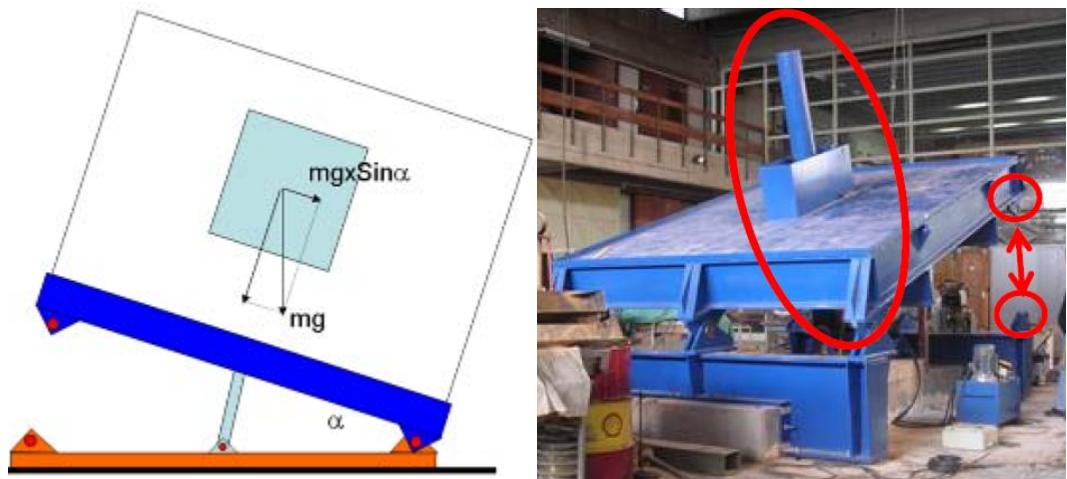
Fig. 10 Lateral load on tilting table

In this part of the study, two, full-scale (1/1) traditional one-storey masonries, were tested. Since construction of a shaking table that has a capacity to test full scaled specimen is very expensive and time consuming, an alternative testing method was prepared. For that aim a tilting table is designed (Fig. 10). The aim of this test was to simulate the earthquake acceleration on masonry houses which acts at all points rather than just the roof or slab level that common static loading setups assume. The horizontal load is applied by making use of the gravitational acceleration as the test house is inclined. The mass of the masonry house walls is considerably large and should not be ignored during testing. The mass of the walls play an important role especially in out-of-plane bending direction. The effect is exacerbated if the roof supports are also acting on that wall which receives earthquake acceleration orthogonal to the supporting wall's plane. Tilting test models enabled application of acceleration at all points of the test house in proportion to the mass of its members. A lateral load, which is equal to weight of the structure multiplied by the sinus of the angle, is applied on specimen laterally.

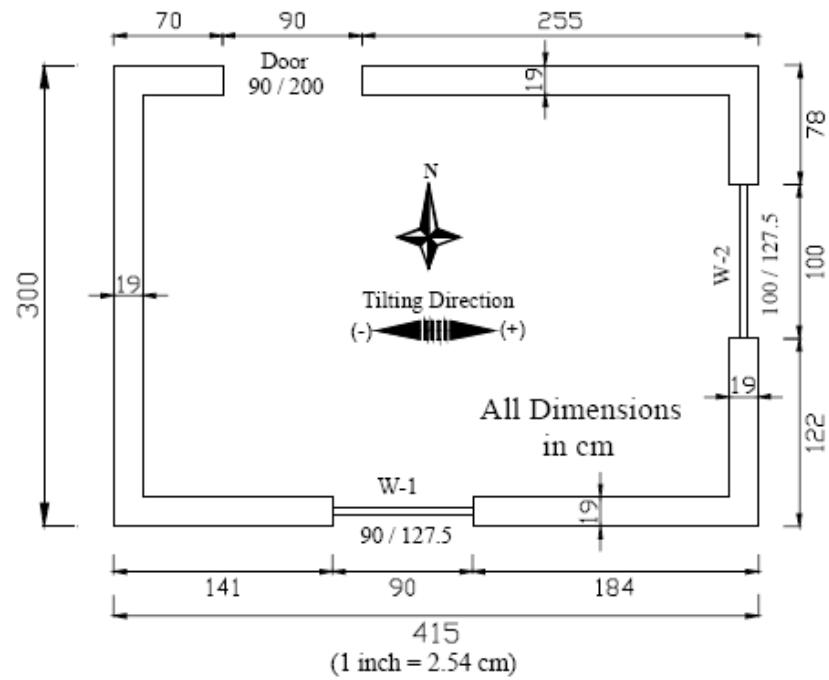
Fig. 11 Plan view of full scale masonry house

Two full scale houses were tested; the first house was tested without strengthening, and the second one was tested after applying post-tensioning with STR chains (STCs). Two full scale one-storey masonries with dimensions of $3\text{m} \times 4\text{m} \times 2.40\text{ m}$ width, length, and height, respectively, were identically constructed on the tilting table by an experienced mason. Full scale prototype test specimens had same geometrical properties with the 1/10 model house. Both models were identical and had a single room with two windows and one door (Fig. 11).

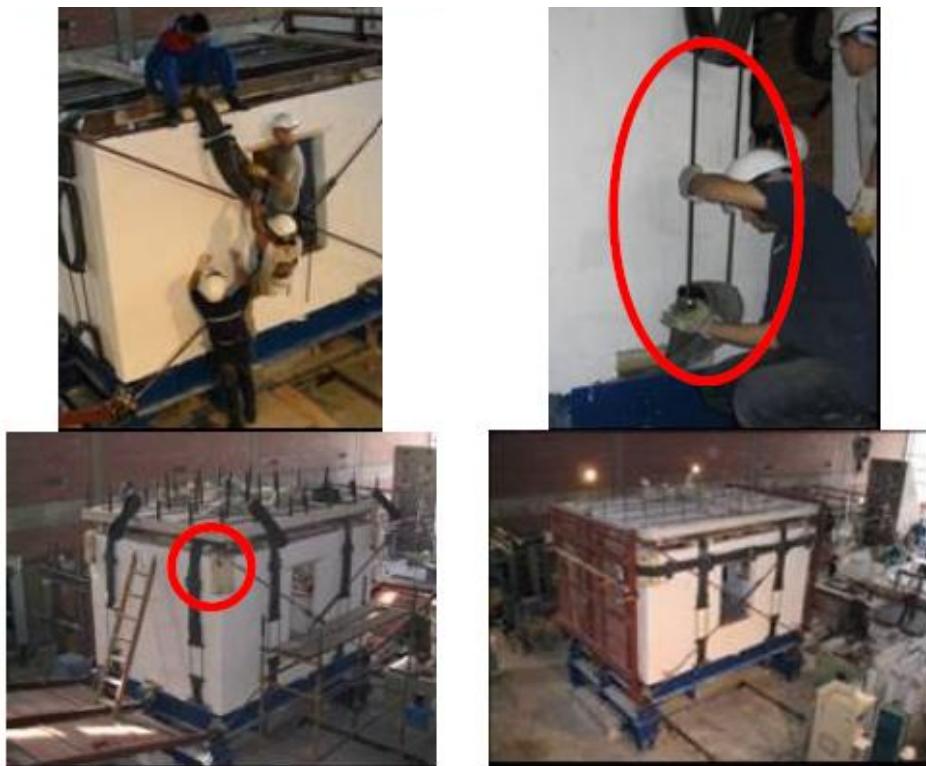
Fig. 12 Strengthening operation of the test specimen

In order to simulate the weight of the roofs found in practice, both models were subjected to 55 kN roof weight (4.7 kN/m^2) carried by five wooden logs placed in tilting direction onto reciprocal walls. The second specimen was post-tensioned by applying

STCs in two directions (9 STCs in vertical and 1 peripheral STC in horizontal directions). The strengthening operation in both directions was applied. First, 1.5 bricks were extracted from the bottom end of the wall, in order to reduce stress concentration on the tire and wall, semi-cylindrical logs were placed in the created gap at the bottom and top ends of the wall. Both wooden logs were bonded to the wall with cement paste for even load distribution. The STCs were then passed through the gap below the bottom wooden log and above the top wooden log, thus wrapping the wall. The post-tensioning load of 50 kN imposed on the walls was applied by turning the bolts of the STR connectors. 8 semi-cylindrical logs were placed on the upper sides of each corner of the walls underneath the horizontal STC (Fig. 12). The STC was then stretched, up to 25 kN, horizontally along the periphery of the model under the roof level. The lateral compression capacity of the bricks are smaller compared to the vertical compression load capacity. Furthermore, there were only two layers of bricks above the windows while a larger number of bricks were available in the vertical direction. Although the capacity of each brick was about 300 kN the load was kept smaller due to the tensile strength and time dependent behavior of scrap tires. Additional vertical load applied by the heavy roof was also taken into account.

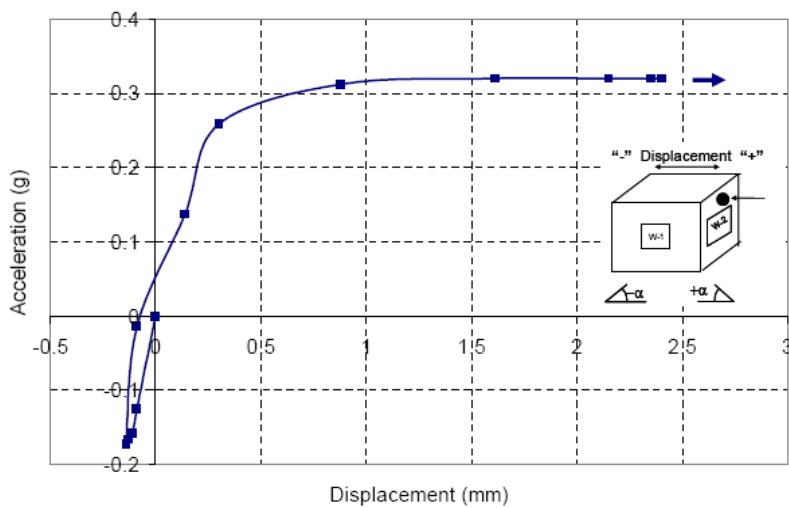
Fig. 13 Out-of-Plane displacement vs load graph of un-strengthened model

The test of the first model was conducted with the aim of investigating the behavior of un-strengthened full-scale masonry building and determine its capacity for comparison against strengthened model results. The test building was exposed to simulated static cyclic reversal earthquake acceleration. Measured displacement values of walls in out-of-plane directions are given in Fig.13. During the tilting table experiment, the lateral load from the roof was transferred onto the walls in out-of-plane direction as a sinus function of the tilting slope. The load was further transferred from out-of-plane to in-plane direction walls through the bricks and mortar of the walls that supports the beams. During this transfer of load, the shear stress concentration increased, especially around the corners of the walls, doors, and windows. The walls showed linear behavior until the model collapsed suddenly at 18.8 degrees of tilting under the lateral acceleration force of 0.31g in positive tilting direction (Fig. 14). No clear crack formation was observed on the surface of masonry walls prior to the sudden collapse. With the increase of the value of the applied earthquake force, the wall displacements increased linearly up to the collapse of the structure showing brittle behavior due to the characteristics of the used material in the construction of the model. The loading was force controlled, therefore, the response beyond the cracking immediately led to mechanism formation and total collapse. Most probably the collapse mechanism would have been the same during an earthquake. The responses obtained from un-strengthened 1/10 scale lab specimens also supported the brittle behavior of un-strengthened masonry.

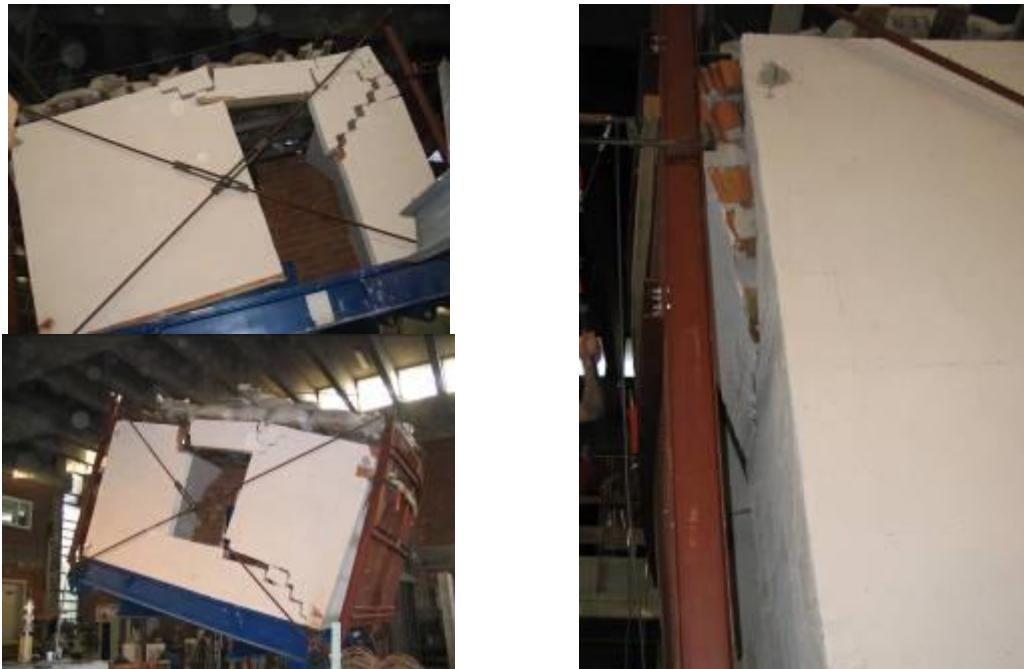
Fig. 14 Failure of original masonry house at an angle of 18°

The crack formations initiated around the corners of the window and the door when the level of the shear stress reached the limits of the walls in in-plane direction (see Fig. 14) and continued diagonally. The failure of the in-plane walls, exposed the out-of-plane walls to an increased load beyond their capacity in that direction considering second order nonlinear effects, thus leading to mechanism formation and a sudden total collapse of the structural system. Contrary to the general expectations, the walls in out-of-plane direction did not fail at the base level but followed a semi-circular inverted path or a flat line at the 1/3rd of the height. The wall was not only supported at the base but also at the two edges along the corner joints with the perpendicular walls. Therefore, the post-tensioning was expected to greatly improve the out-of-bending behavior of the walls that are loaded in their orthogonal direction.

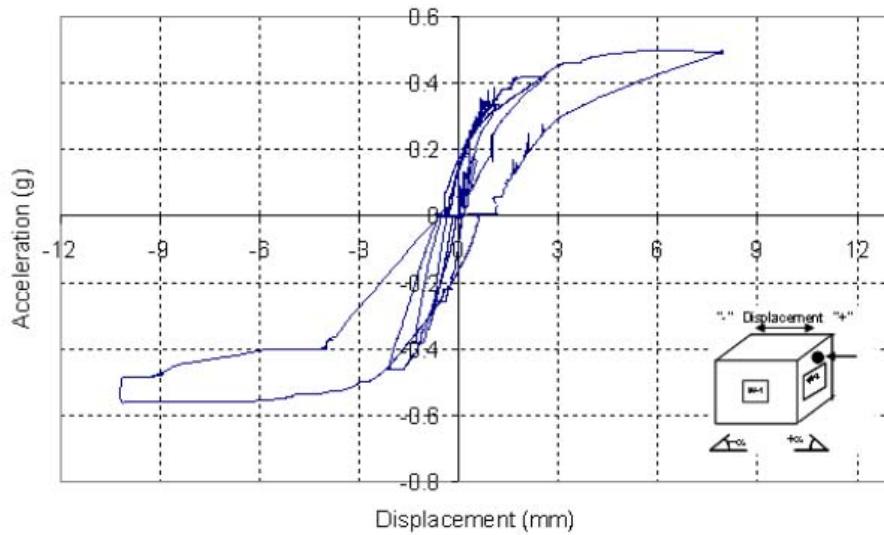
Fig. 15 Out-of-Plane displacement load graph of strengthened model

The location and direction of the cracks formed during the first full scale test were helpful in deciding the location of the post-tensioning STCs on the walls for the second model. 50 kN and 25 kN post-tensioning forces were applied on the walls in vertical and in horizontal directions, respectively. The magnitudes of post-tensioning forces were determined according to the strength properties of scrap tires and building materials. The second model (strengthened with scrap tires) was subject to quasi-static earthquake simulation acceleration by the tilting of the table. The model resisted tilting up to 34.4 degrees which was equivalent to 56% of the gravitational acceleration (i.e., 0.56 g). The measured diagonal displacement values of the out-of-plane are given in Fig. 15. The crack patterns of shear and out-of-plane walls are illustrated in Fig. 16.

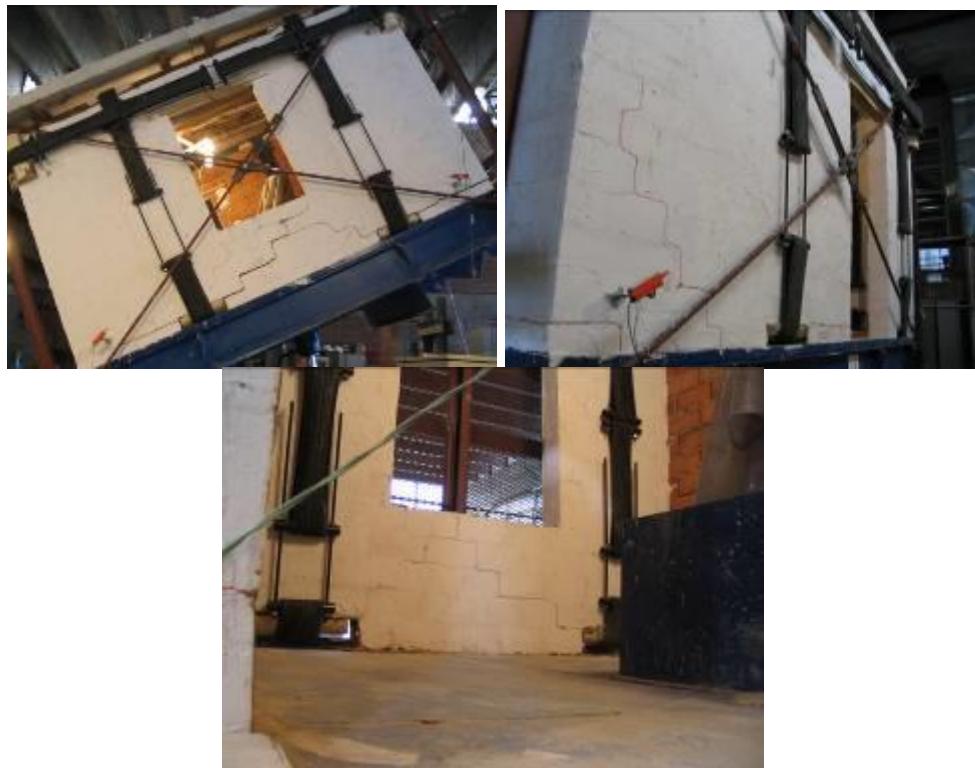
Fig. 16 Cracks of strengthened full scale specimen

The formation characteristics of cracks, location of cracks, ductile behaviour of the strengthened building were similar to the specimen S2 in 1/10 model structure. Both 1/10 scaled and full scale prototype structures horizontally cracked at the bottom which was an indication of rigid body translation.

The condition of the strengthened house after 34 degrees inclination showed that the applied post-tensioning forces had altered the directions of the cracks. Moreover, the cracks were much smaller in numbers and size compared to the first model. They were mostly concentrated at the base and under the windows while in the first model the wall cracks were very large and located at all levels, especially in diagonal direction around the corners of the window and the door. It is also important to note that, when the table was brought back to its original flat position, all cracks were closed and the strengthened model returned to its original shape due to the elastic behavior of scrap tires. Furthermore, the crack pattern of the strengthened model nicely matches with the crack pattern observed in 1/10 scale models.
