Fatigue Damage of a Half-through Concrete-filled Steel Tubular Trussed Arch Bridge in China

In this study, main cause of the cracks found in a half-through CFST arch bridge during the daily inspection in April 2013 was identified. Fatigue life was estimated by FE analysis and hot spot stress (HSS) method. Furthermore, an improved design of the bridge was suggested.

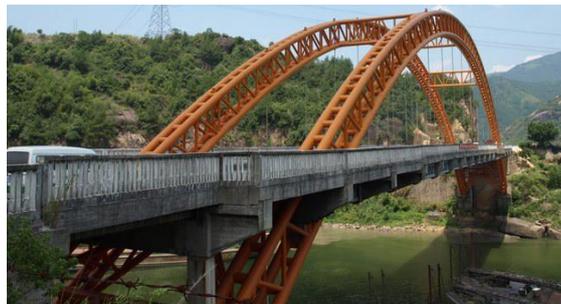
Fig. 1 Photo of bridge

This bridge is a half-through CFST trussed arch bridge in Fujian Province, China, as shown in Fig. 1. The length of the bridge is 166.84 meters, and its main span is 136 meters. General layout of the bridge is shown in Fig. 2. It opened to traffic in January 1998.

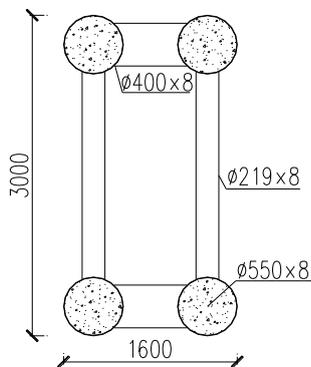
Fig. 3 Cross sections of main arch rib(Unit: mm)

The trussed arch rib section is 3.0 meters deep and 1.6 meters wide. The chord tubes use $\Phi 550\text{mm} \times 8\text{mm}$ steel pipes filled with C40 (concrete with compressive strength of 40MPa) and web members use $\Phi 219\text{mm} \times 8\text{mm}$ steel pipes, as shown in Fig. 3. The steel grade is Q235 (steel with yield stress of 235MPa).

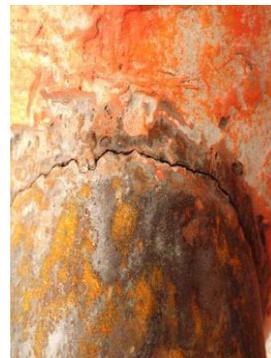
Fig. 4 Example of crack

In April 2013, cracks were found in the connections of main arch chord and web member during the daily inspection, as shown in Fig. 4. In total, there are nine cracks in the bridge, comprising eight in the left side of the main arch rib and one in the right side (from XIKOU to XIONGJIANNG, left hand is left side and right hand is right side). The notation of arch chord is shown in Fig. 5. The position and length of cracks are summarized in Table 1. Specific distribution of cracks is shown in Fig. 6 and Fig. 7.

It used unilateral groove weld with the groove depth of 6mm. Through the magnetic particle testing and ultrasonic testing, no weld defects such as crack, flash welding seam, burn through, arc pit, porosity, slag inclusion, bite edge, incomplete fusion, and lack of penetration were found. So the welding quality problem is excluded from the cause of cracking.

(1) Because the average daily traffic of the bridge has reached 7435 in 2013, and overweight vehicles were more than expectation, we had reasons to believe that the main cause of the cracking should be fatigue by the vehicle loads.

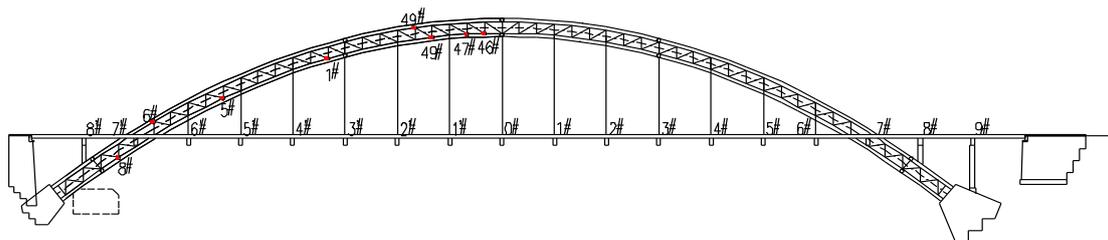
Fig. 6 Specific distribution welded cracking of left side

No.	Position	Length
1#	Left, between 3'# and 4'# suspender, Left, 11'#tilted web member and arch chord C	220
5#	Left, between 5'# and 6'# suspender, Left, 17'#tilted web member and arch chord C	200
6#	Left, between 6'# and 7'# suspender, Left, 20'#tilted web member and arch chord A	160
8#	Left, between 7'# and 8'# suspender, Left, 23'#tilted web member and arch chord C	220
35#	Right, between 2'# and 3'# suspender, Left, 7'#tilted web member and arch chord H	180
46#	Left, between 0'# and 1'# suspender, Left, 2'#tilted web member and arch chord D	200
47#	Left, between 0'# and 1'# suspender, Right, 2'#Vertical web member and arch chord D	250
49#	Left, between 1'# and 2'# suspender, Left, 5'#tilted web member and arch chord C	170
49'#	Left, between 1'# and 2'# suspender, Left, 5'#tilted web member and arch chord A	200

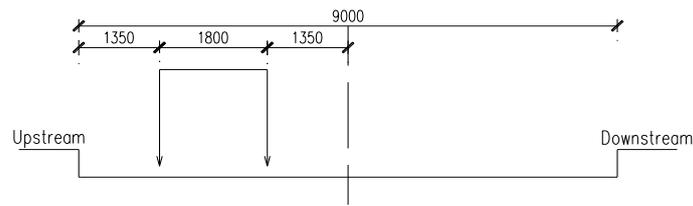
Fig. 10 Vehicle layout (Unit: mm)

According to vehicle Investigation, if the truck is filled with sand, its weight may be 38 ton; and if the truck is filled with stock, its weight may be 42 ton. As shown in Fig. 9, the truck with the weight of 40 ton was used to calculate the fatigue damage. The position of vehicle load is shown in Fig. 10.

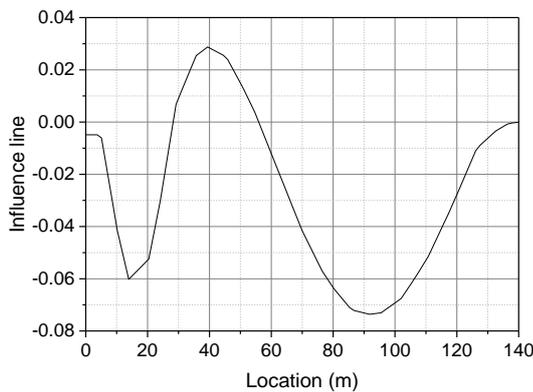
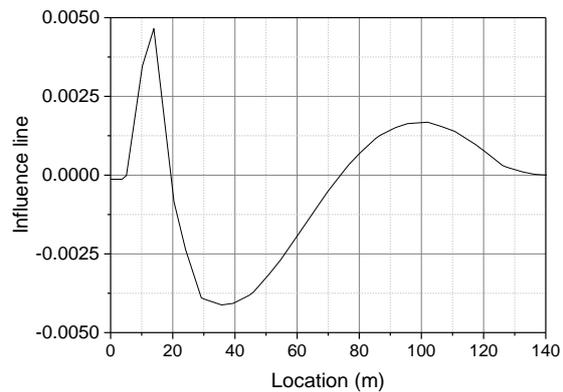
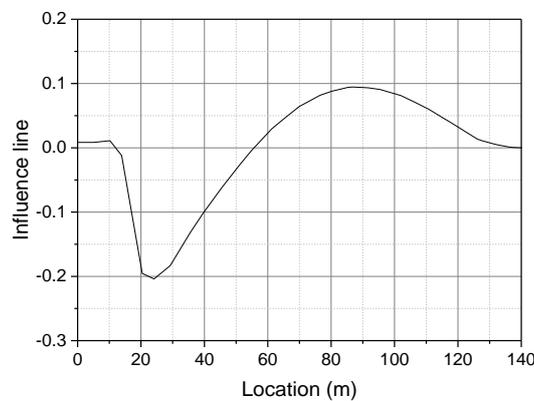
Fig. 11 Influence lines

Fatigue life of the 6# crack of CFST joint was calculated. The influence lines of axial forces and bending moment in chord tube and web member at the joint are shown in Fig. 11.

(a) Axial force of chord tube

(b) Bending moment of chord tube

(c) Axial force of web member

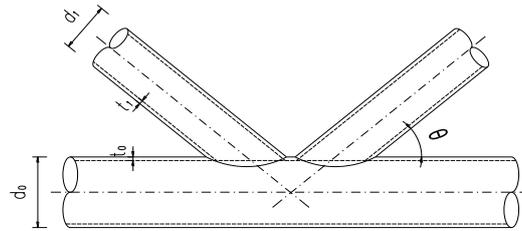
Fig. 12 Range of structural parameters valid for the method

Range of structural parameters valid for the method is shown in Fig. 12. It should be noted that the diameter-thickness ratio of this CFST arch bridge is 34.4, which is a little larger than applicable range of the design code. Nevertheless, the code was applied since the estimated fatigue life by the method will be underestimated due to the fatigue performance improvement by CFST.

Range of validity: diameter ratio: $0.30 \leq \beta \leq 0.60$, diameter-thickness ratio: $24 \leq 2\gamma \leq 60$, thickness ratio: $0.25 \leq \tau \leq 1.00$, angel: $30^\circ \leq \theta \leq 60^\circ$.

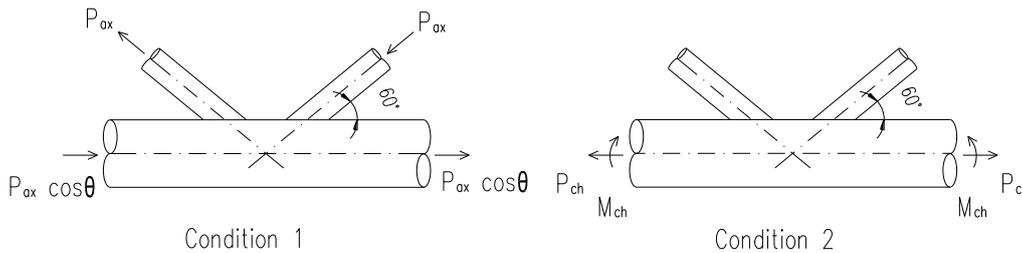
Fig. 13 Two basic fatigue load cases

The axial forces and bending moments in the joint can be treated as a combination of condition 1 (basic balanced axial loading) and condition 2 (chord loading), as shown in Fig. 13.

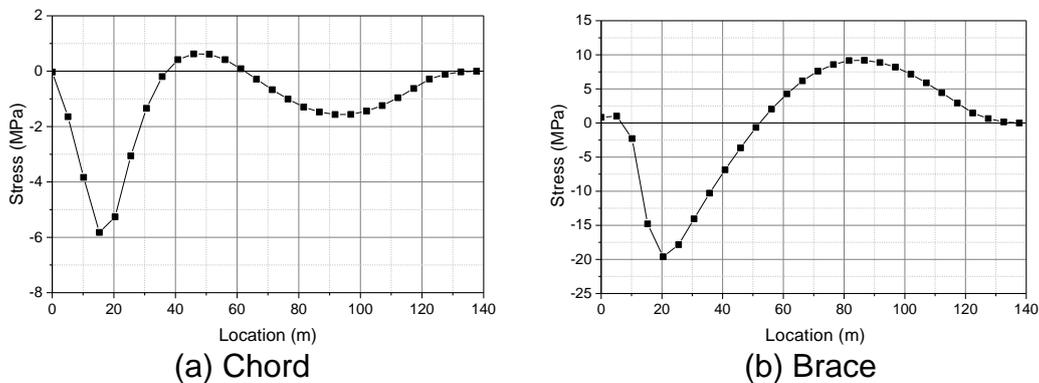
Fig. 14 Nominal stress (Unit: MPa)

In order to take into account the effects of the secondary bending moments, nominal stress ranges have to be multiplied by magnification factors, which are given by EN 1993-1-9. So,

The design values of the nominal stress for chord and brace are shown in Fig. 14.

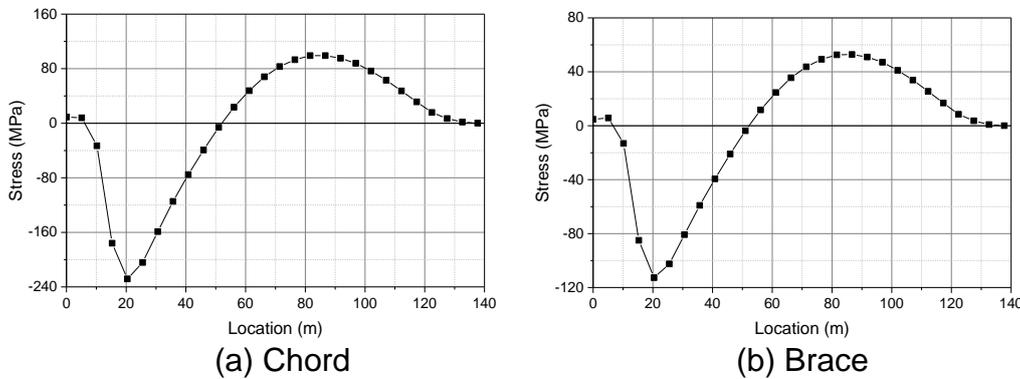
Fig. 15 HSS (Unit: MPa)

A partial safety factor for fatigue loading and fatigue strength needs to be taken into consideration for design. However, the partial safety factor is not considered because the aim of this study is just fatigue life estimation of an existing bridge. HSS ranges calculated by the following equations are shown in Fig. 15.

$$S_{rhs, chord} = SCF_{ch,ax} \sigma_{brace,ax} + SCF_{ch,ch} \sigma_{brace,ch} \quad \text{and} \quad S_{rhs, brace} = SCF_{b,ax} \sigma_{brace,ax}$$

So, SCF and number of cycles to failure according to HSS method and correction coefficient method obtained for these two conditions are shown in Table 4. Considering the traffic volume on the bridge, the calculated number of cycles to failure roughly corresponds to 7 years.

It results in the reduction of SCF and HSS ranges as shown in Table 6. When thickness is 16mm, HSS ranges are lower than the constant amplitude fatigue limit of 84N/mm^2 listed in the reference (Zhao 2001). Therefore no fatigue damage is expected to occur.
