## Relationship between hardness and plastically deformed structural steel elements

### ABSTRACT

A field based non-destructive hardness method is being developed to determine plastic strain in steel elements subjected to seismic loading. The focus of this study is on the active links of eccentrically braced frames (EBFs). The 2010/2011 Christchurch earthquake series, especially the very intense February 22 shaking, which was the first earthquake worldwide to push complete EBF systems into their inelastic state, generating a moderate to high level of plastic strain in EBF active links for a range of buildings from 3 to 23 storeys in height. Plastic deformation was confined to the active links. This raised two important questions: what was the extent of plastic deformation and what effect does that have on post-earthquake steel properties? A non-destructive hardness test method is being used to determine a relationship between hardness and plastic strain in active link beams. Active links from the earthquake affected, 23-storey Pacific Tower building in Christchurch are being analysed in the field and laboratory. Test results to date show clear evidence that this method is able to

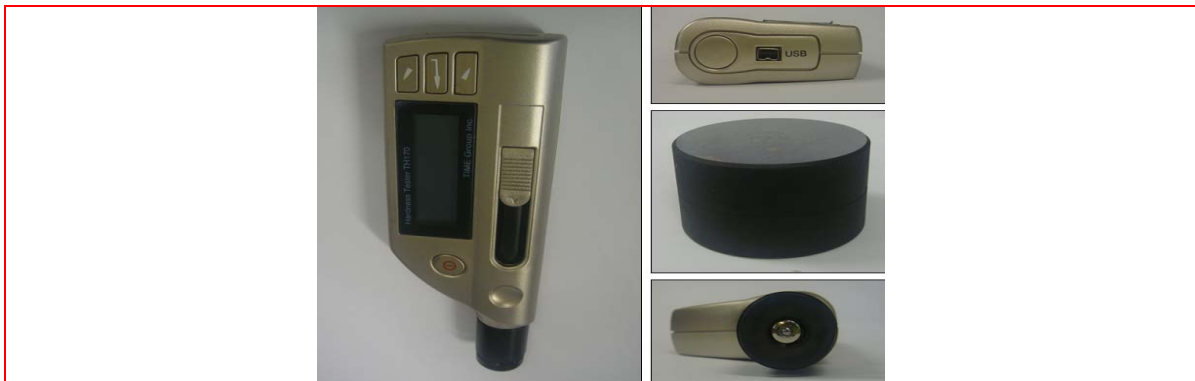
Fig. 1 Integrated portable Leeb hardness tester Th170

## **2. Hardness technique**

Since this is a portable instrument it is very convenient and easy to use in the laboratory as well as inside damaged buildings. However, these devices are prone to inaccurate readings if the test piece is not prepared adequately, especially with the requirements on the surface preparation and minimum weight of the test piece according to the instruction manual of the TH 170 (Beijing TIME High Technology Ltd, 2007). A minimum test piece weight of 5kg is recommended by the manufacturer and surface roughness less than or equal to 1.6 microns has been found by the principal author to be necessary for accurate test results. Hardness tests were conducted on the test specimens prepared according to ASTM Standards (ASTM: E18-11, 2012) for Rockwell hardness of metallic materials.

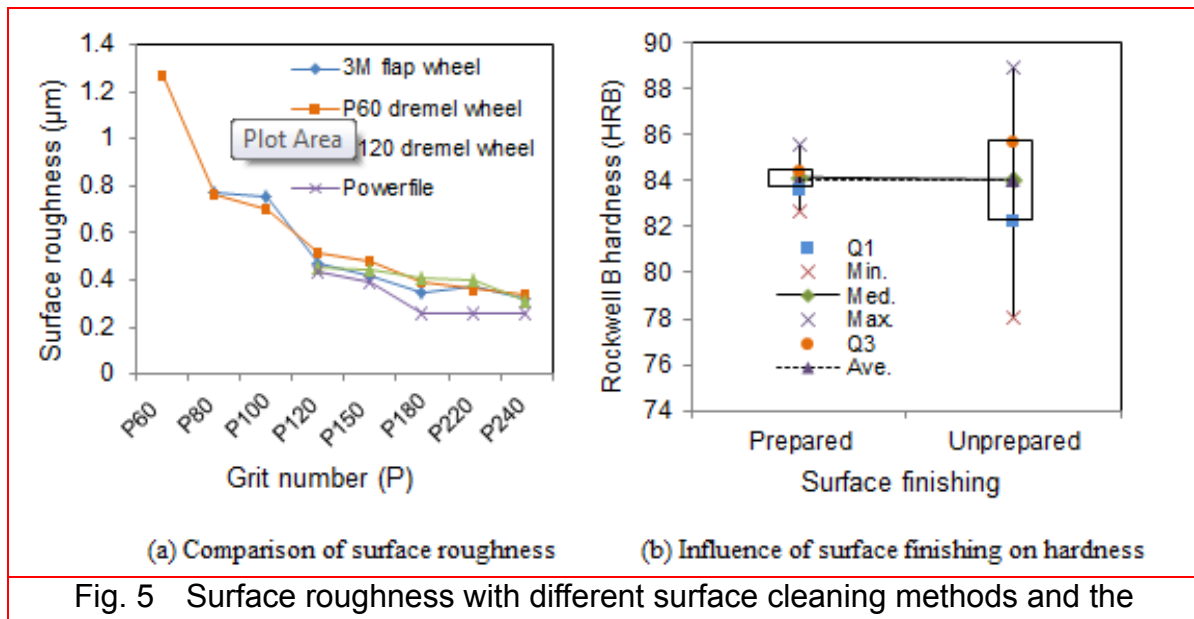
Surface roughness in microns ( $\mu\text{m}$ ) is plotted against different grits (P) from the three methods explained in section 3.2, and presented in Fig. 5(a). The test results show the roughness on all prepared surfaces. As all of these are less than the 1.6 microns recommended for the TH170 operation, it can be considered that any roughness below P60 would be sufficient to carry out TH170 hardness measurements accurately as given in Section 3.1. Fig. 5(b) describes the influence of surface preparation on hardness values. Hardness readings from as-received specimens are scattered over a wide range compared to the prepared specimens. This indicates more accurate hardness could be achieved from a specimen properly prepared.

In Fig. 5(a), the grit number P60 gives the highest the surface roughness ( $R_a = 1.27\mu\text{m}$ ) whereas P240 gave the finest surface achieved in this study. The test results were than compared to identify the best cleaning method out of the three discussed in previous section to achieve the most cost and time effective surface roughness for the portable hardness tester TH170. Challenges in adopting the best method involves access to the test site and location, geometry of the sections, availability of appropriate tools and materials and the safety of the building specially in earthquake effected zones and building structures. There is significantly greater variation in the Rockwell and Leeb readings for the unprepared surface and a slight difference in the average value. This highlights the need for surface preparation to achieve a roughness of  $R_a < 1.6$  microns.

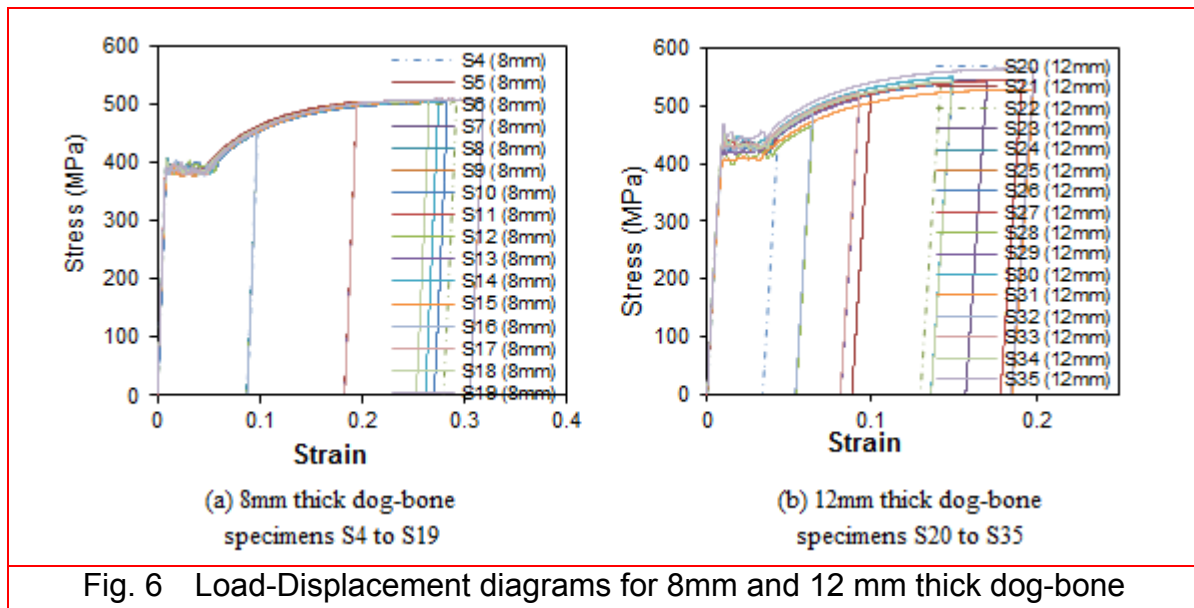
Fig. 6 Load-Displacement diagrams for 8mm and 12 mm thick dog-bone

This section presents tensile test results for 8mm and 12mm thick dog-bone specimens. For different strain demands, load against the displacement graphs were plotted and the hardness was measured before and after the tensile testing. Load-displacement diagrams for 8mm thick specimens S4-S19 are presented in Fig. 6(a). Specimen S1 was strained to failure in order to determine the overall force-displacement characteristics over the full plastic strain range. Specimens S2 and S3 were used as trial specimens. The target strains were set as 5%, 10%, 15%, and 20%, however, due to test setup flexibility, the strain achieved was slightly different. Other mechanical properties, i.e., yield strength, ultimate tensile strength, yielding and plastic deformation behaviour of all the specimens is same.

Fig. 6(b) represents load-displacement graphs for 12 mm thick specimens S20 – S35. Targeted strains set for these specimens were 2.5%, 5%, 10% and 15%; achieved strains were slightly different. The maximum yield load obtained from the 12mm specimens was about 65kN, which is 15kN higher than the maximum yield load of 8mm thick specimens. Unlike the 8mm thick specimens, a small inconsistency was observed within a few 12 mm specimens. Hardness test results in Fig. 7 don't show any dramatic changes due to these minor inconsistencies in plastic behaviour.

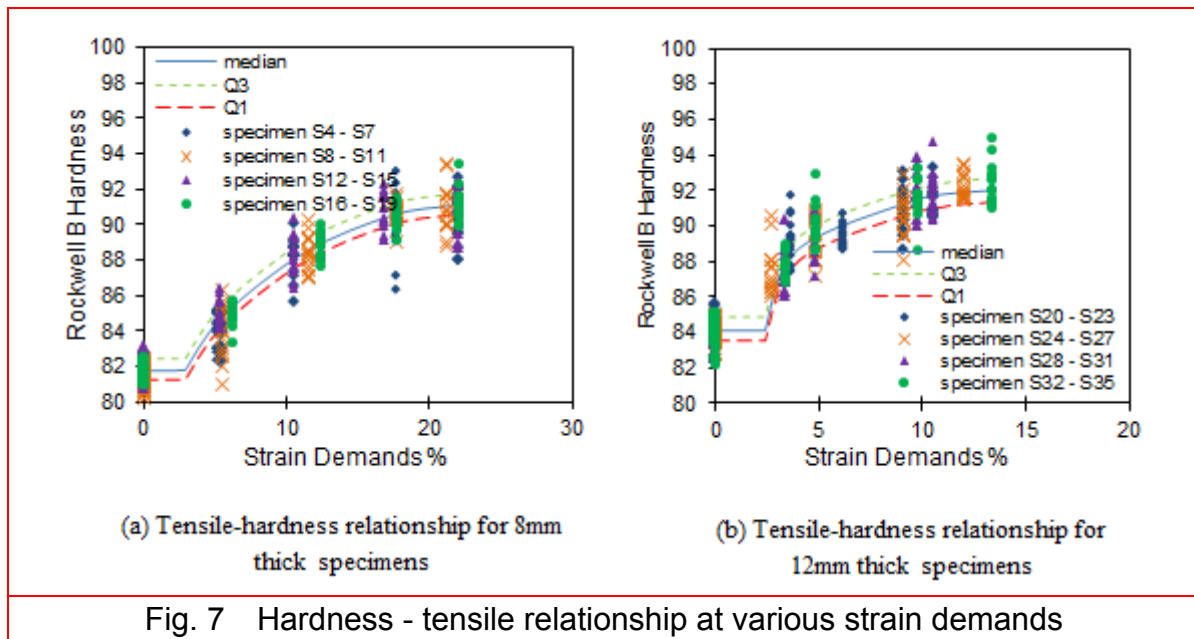
Fig. 7 Hardness - tensile relationship at various strain demands

Measured hardness against plastic strain from the dog-bone specimens is presented in Fig. 7. Hardness measurements were undertaken with the Rockwell B bench top hardness tester, with the readings for different specimens being taken on different days. For the hardness tests, specimens were grouped from lowest to highest achieved strain levels as a set, and this was repeated for up to four sets. At zero strain, Rockwell hardness for 8mm thick specimens ranged from 79.6 to 83.2 and for 12 mm thick specimens ranged from 82.2 to 85.6. Hardness measurements up to the beginning of plastic strain were considered to be constant and it were plotted following the load-displacement diagram shape. At each strain level, 15 hardness readings were taken and recorded in four categories; average, minimum, maximum and median. Hardness gradually increased with increasing plastic strain in both the cases as shown in Fig. 7. It was observed, the majority of hardness values fall between the first and third quartile (Q1 and Q3), indicating that this relationship is within the acceptable limits. Based on monotonically strained specimen test results, the relationship between plastic strain and hardness can be determined and use to calculate residual plastic strain demand.

Fig. 7 shows, curves meeting the zero strain hardness values at the plastic strain corresponding to the end of the yield plateau. This intersection point which is got from the force-displacement diagram in Fig. 6 are based on the fact that the material strength does not increase above yield in the yield plateau region, meaning that the hardness will not increase in that region either. For Grade 300 steel that extends out approximately 2.8% plastic strain

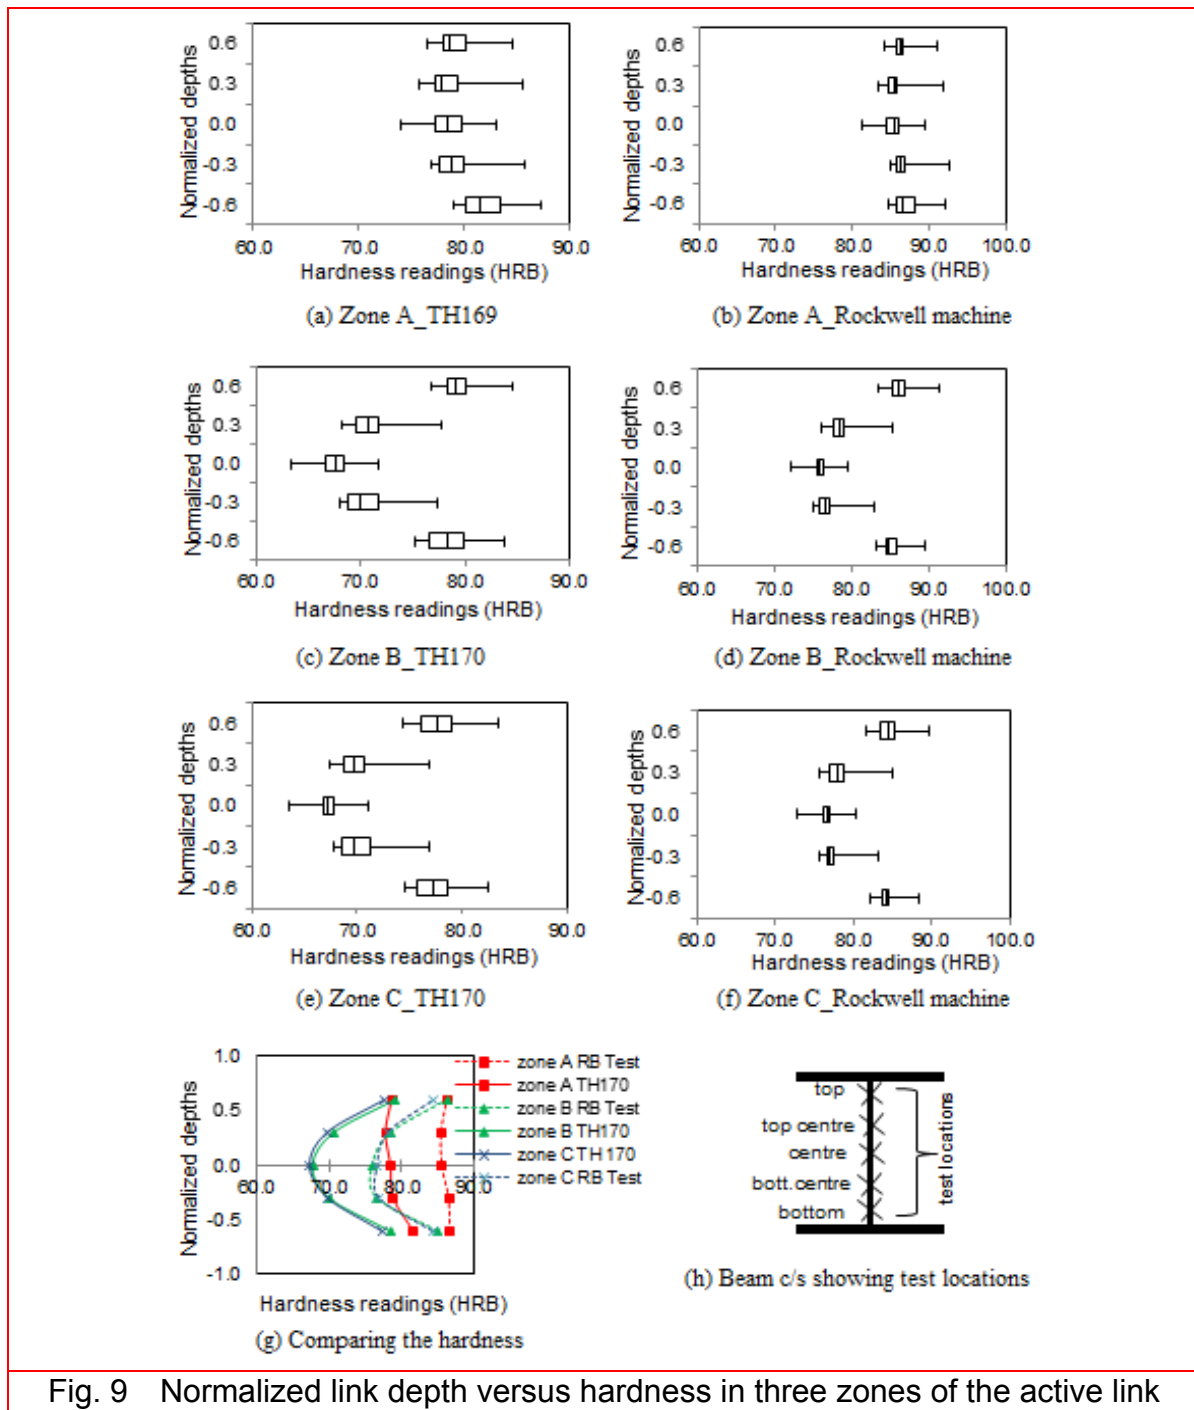
Fig. 9 Normalized link depth versus hardness in three zones of the active link

Rockwell B hardness for both testers, as a function of normalized link depth is presented in Fig. 9 (a) to (f) and (g) represents a comparison of hardness over the three zones.

Accuracy of the hardness method can be predicted by comparing the proximity of the box plots. It is noted that the hardness measurements in these tests were carried out before adopting the proper surface preparation technique discussed in Section 3.2 and 6.1. These normalized link depths clearly demonstrate the difference in hardness between the three test zones using the two test methods as shown in Fig. 9(g). Rockwell B machine values were between 10 to 8 points higher than the Leeb TH170

tester hardness values. The difference in hardness between these two methods could be due to the geometry of the section and the mass effect of the test specimen. Both machines clearly show that Zone-A achieved the highest hardness values for both the methods. Constant high hardness values through the depth of the web in Zone-A indicates that the web of the active link had undergone appreciable in-plane plastic deformation during the earthquake, while the panel and beam zones, B & C, had much lower levels of plastic strain at the midpoints of the webs.

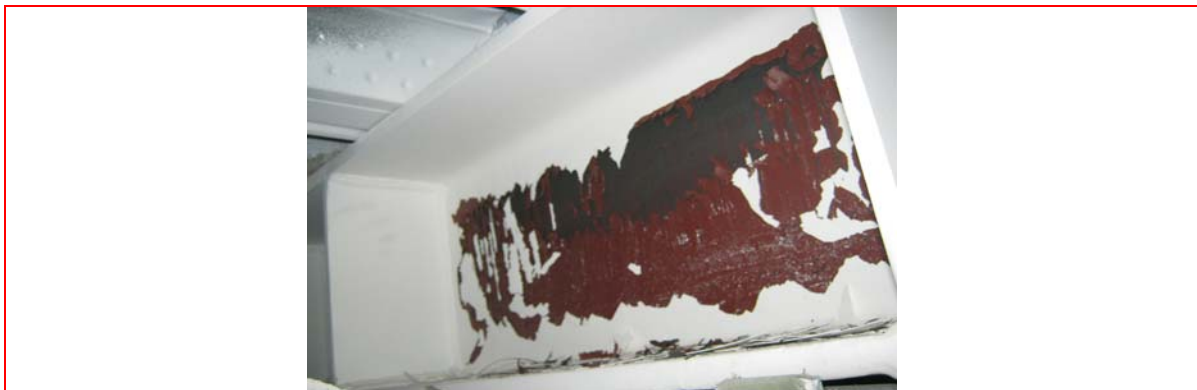
Fig. 10 Active link beam from Club Tower, Christchurch which has undergone

It was observed that the panel and beam zone plastic strain distribution could not be explained by the earthquake actions, hence further studies were required to confirm the initial results and an alternative solution had to be found. Visual inspection of the hot rolled yielded active link in Fig. 10 showed the earthquake induced yielding was concentrated in a band in the middle of the web and either did not extend to the root radius at the web top and bottom or was appreciably less in the top and bottom quadrants. In addition, the paint flecking started approximately at the centre of the web and stopped close to the k-region of the section where the manufacturing plastic strain was measured. This interesting phenomenon was identified during this investigation and is reported by Nashid et. al. (Nashid et al., 2013) and a similar investigation carried out by Tide in 2000 (Tide, 2000).

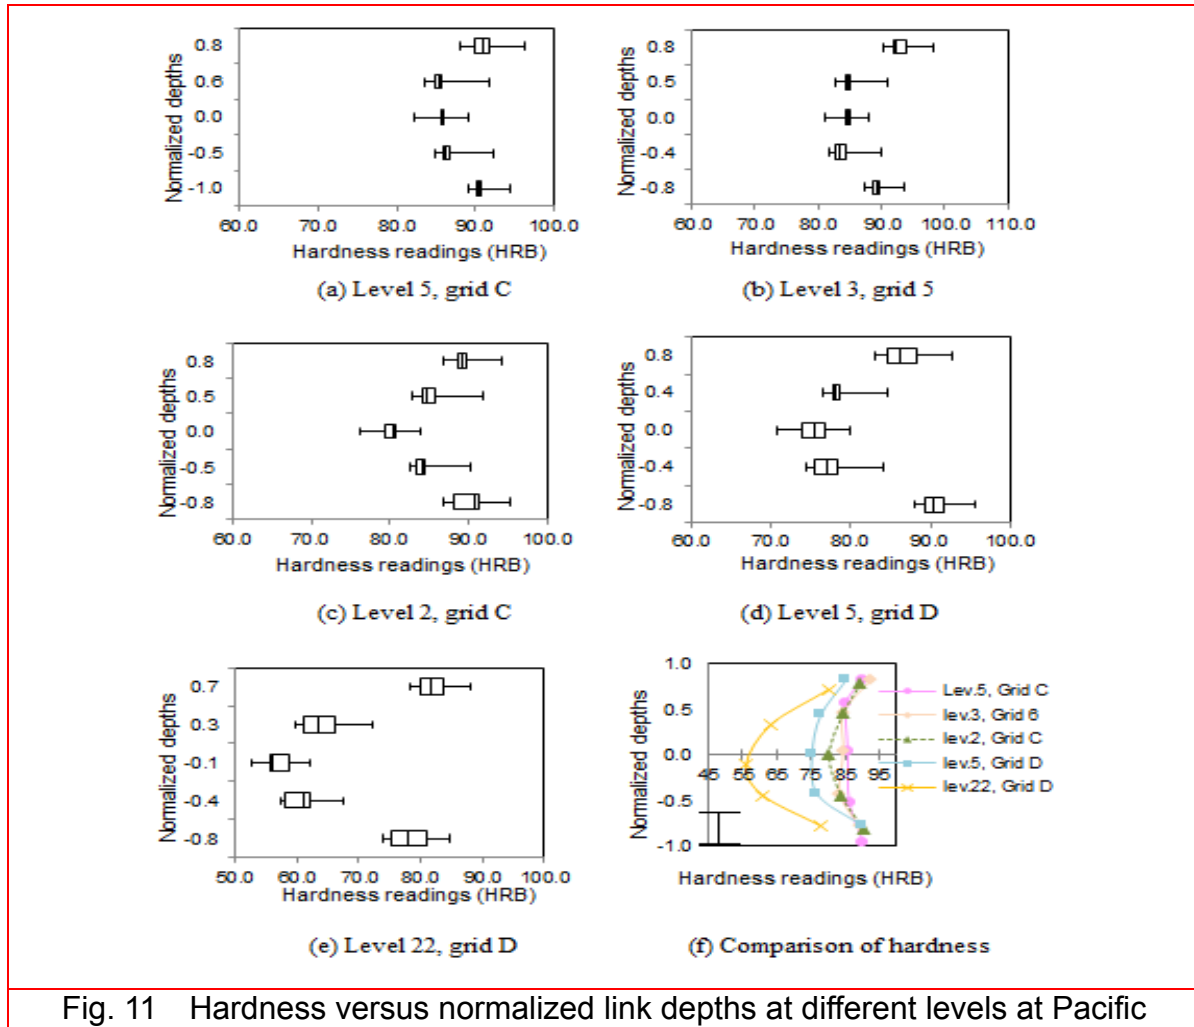
Fig. 11 Hardness versus normalized link depths at different levels at Pacific

Further investigation was carried out on active links at different floor levels in Pacific Tower to compare the laboratory test results with onsite test results. Fig. 11(a) to (f) represents the Rockwell B hardness measured at different levels and plotted against the normalized depth of the sections, and the box plots from (a) to (e) indicate the accuracy of the readings. High hardness close to the flanges was observed at all the locations and hardness drops at the centre of the active beams, similar to the laboratory test results. The measured Rockwell B hardness at level 22 was less than that for the other floors. It was observed that two different active links on different grids at the same level were showing different hardness results, because the earthquake demands on the building were different in the two principal axes of the building. The hardness of these beams was previously measured by Holmes Solutions Ltd (HSL) and reported by Gardiner et. al. in 2013 (Gardiner et al., 21-22 February 2013). The HSL

hardness readings and visual observation of yielded links throughout the building were later analysed by the first author and showed inelastic demand in the active links was greatest around levels 5 and 6 and negligible above level 16.

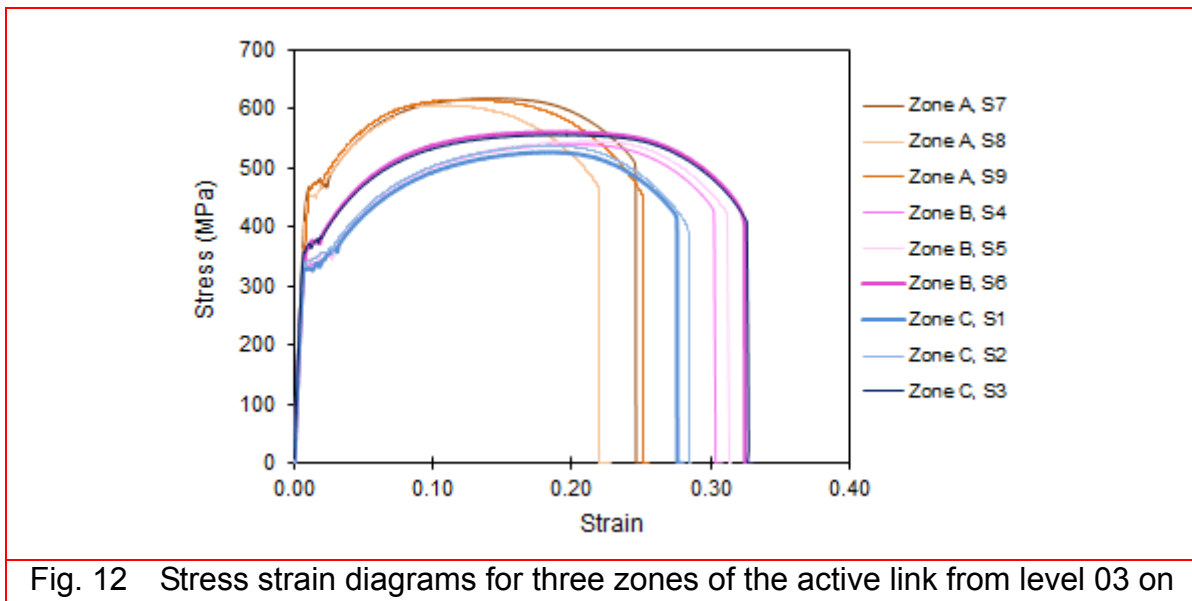
Standard dog-bones were cut from the cyclically deformed active link beam from level 3 of Pacific Tower, to carry out tensile tests. Specimens S1, S2 and S3 were extracted from the beam zone (Zone-C), Specimens S4, S5 and S6 from the panel zone (Zone-B) and Specimens S7, S8 and S9 from the active link zone (Zone-A) as shown in Fig. 8(a) and (b). The orientation of the specimens was arranged to investigate the plastic deformation in three positions of the web. The stress-strain curves for the 9 specimens from the three zones of the active link beam are presented in Fig. 12.

This shows that all specimens from Zone - A ( S7, S8 & S9) have essentially the same shaped curves and yield stresses, which is consistent with the visually observed significant plastic deformation from the earthquake and matches the hardness profile showing similar hardness values across Zone-A. For zones B & C, tests S1, S4, S2 & S5, have similar shaped yield curves and yield stresses, which is to be expected, as the centres of these specimens are in the centre of the web, which for these zones have not yielded. Tests S3 & S6 are near the flange have the same shaped stress-strain curve, but the flow stress has increased over that for tests S1, S4, S2 & S5, showing there has been pre-earthquake plastic deformation in the region of the web near the flange and confirming the hardness results in the Fig. 9. The stress-strain diagram shows that the active link Zone-A has undergone approximately 7-7.5% plastic strain, compared with up to 4% plastic strain in the top and bottom of the webs in Zone-C. The plastic strain in Zone-A is a combination of pre-earthquake strain, termed manufacturing strain, in the top and bottom sections of the webs, and earthquake induced strain across the whole web depth. The results show that the as-received EBF has been plastically deformed due to pre-earthquake straining in the web near the flanges to about 4% prior to the earthquake and this is termed manufacturing plastic strain. This plastic strain is believed to arise from roll straightening at temperatures below 100°C (Tide, 2000), when the web is held vertical as the flanges are cold bent to within tolerances. Based on these results, it is recommended that the hardness is measured in the centre of the web, where there is no significant influence of manufacturing strain, to check for increase in plastic deformation following an earthquake. Similarly, dog-bone tensile specimens have to be taken in the centre of the web, parallel to the flanges if there is a necessity for tensile testing.

- The stress-strain diagrams clearly show the link zone achieved higher stress with reduced elongation compared to the other zones, indicating the middle of the link zone has undergone plastic strains of up to 7.5%.
