Local cracking stability analysis of super high arch dam

*Peng Lin[1] , Qingbin Li, Dong Zheng, Senying Hu

State Key Laboratory of Hydroscience and Engineering, TsinghuaUniversity, Beijing 100084, China

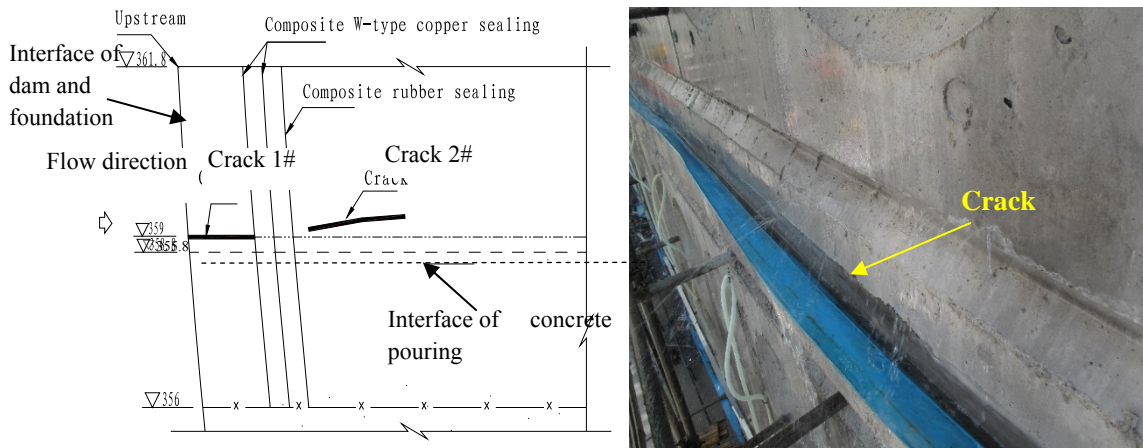
distribution was segmented and discontinuous. The crack 1# of the 20# dam section was located in the upstream side of the deck surface (Fig.1(a)), with a length of 9.74m, and a maximum width of 0.12 mm.

(a) Cross section map (b) Snapshot of dam cracking position
Fig.1 The range of horizontal cracks of 20# monolith at EL 358.8~361.8m

Figure 1 shows the cracking states at elevation level (EL) 358.8~361.8 m above the upstream surface. If tension stress develops close to cracks, the inability of unreinforced concrete to carry tension may permit the formation of new cracking. Tension stress zones are almost certain to develop in a cracked dam and crack growth is apt to occur on the upstream surface at the junction of the dam and foundation. If water infiltrates the crack, and causes hydraulic fracturing, the cracks propagate and coalesce which has a serious effect on dam structural function and dam safety. Thus, a preliminary analysis based on the assumption that the concrete and rock material is capable of carrying some tension is usually necessary in order to discover the approximate location of the tension areas.

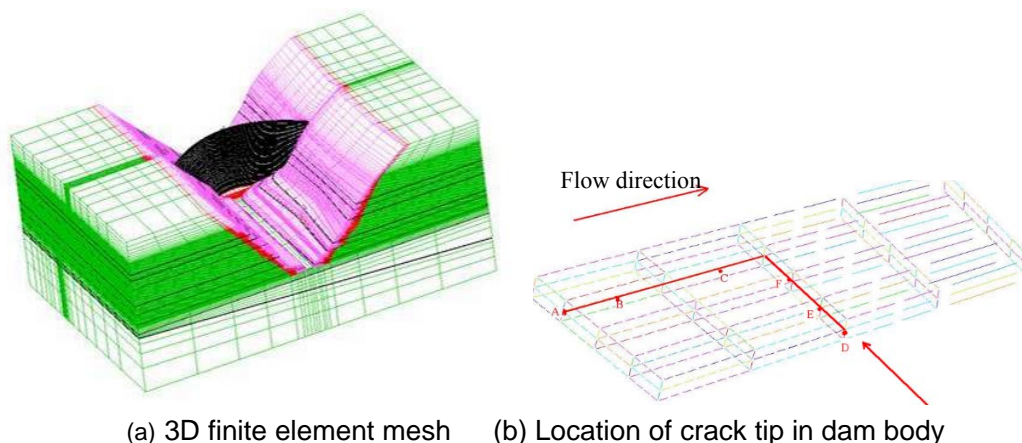
(a) 3D finite element mesh   (b) Location of crack tip in dam body
Fig. 2 3D finite element and local model of the Xiluodu arch dam and its foundation

The cracks were located at EL 358.8m of No.20 dam monolith. To obtain boundary conditions for the cracking region, the larger, vertical direction range for the local crack model was assumed to be about 30m above 358.8 and about 15m below. The vertical distance is 15m from EL 358.8m to interface of dam-foundation. That is, the local model was taken as from EL 342.5m to EL 390.5m. Along the river direction, the cracking model stretched from the upstream face to the downstream face. In the transverse direction, the model stretched from the 19# transverse joints to the 20# transverse joints. In the local model, the crack faces tips were a set of single-nodes, but the nodes along the crack faces are dual nodes, which stretch from crack tip to crack end. The degenerate singularity elements and crack tip nodes are shown in Fig. 2(b).

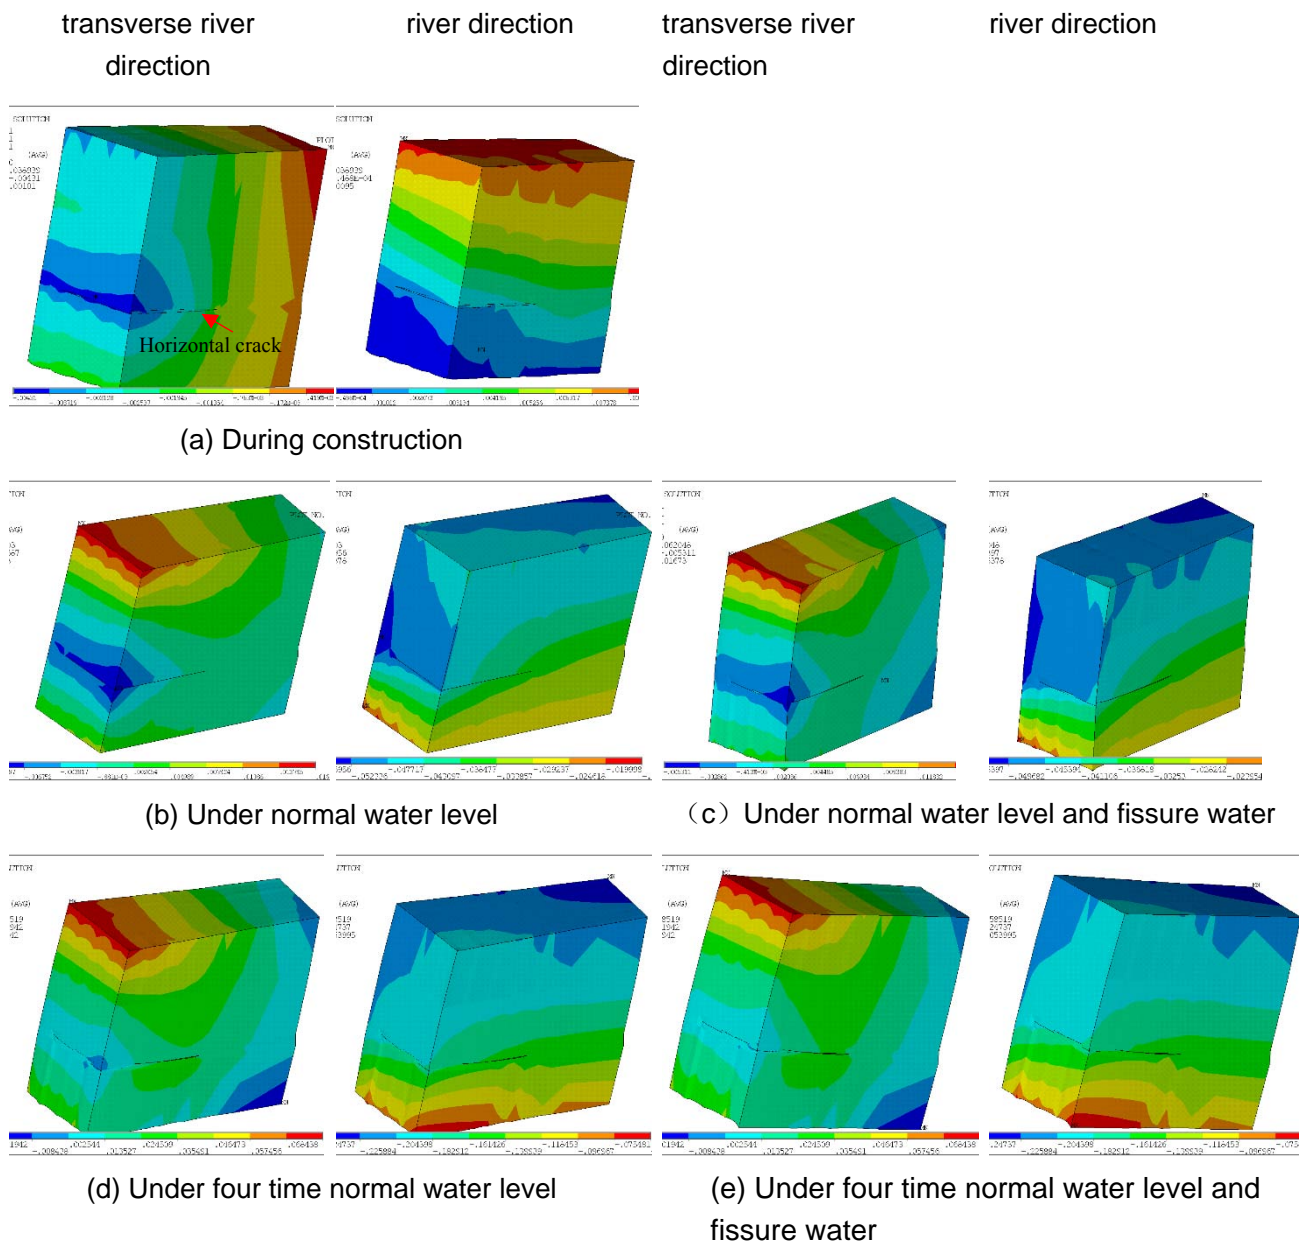
The deformed state of the local crack model during construction is illustrated in Fig. 3(a). It is shown that: the crack faces at EL 358.8m were in a closed state, because the weight loadings played an important role in effecting this. The crack stability during construction analysis results are listed in Table 1. It is shown that the crack tips at the points A, B and C were in a stable state during construction, and the cracks would not propagate in the transverse direction. Meanwhile, the crack tips at points D, E and F were in a stable state, and the cracks would not propagate in the river direction.

The deformed state of the local crack model under normal water loading is shown in Fig. 3(b). It is shown that the crack faces at elevation 358.8 m do not open and are in a closed state. However, comparing this situation with its state during construction, the closure of the crack faces is weakened, the crack tips of the faces are still in a state of compression.

Fig.3 Deformed state of local crack model under different analysis cases

occurs along the crack faces, that is, the crack faces are exposed to a rectangular water head. The deformed state of local crack models under normal water level and fissure water pressure is shown in Fig. 3(c). It is shown that the crack faces at points A, B and C would not open and remain in the closed state. But the crack faces at D, E and F have already opened.

The deformed state of the local crack model under four times the normal water loading is shown in Fig. 3(d). The deformed state of the local crack model under four times the normal water loading level and with fissure water loading is shown in Fig. 3(e).

Due to the weakening effect of the crack, the crack faces along the river are constantly in a state of compression, resulting in the crack faces in the perpendicular transverse direction changing gradually from a state of compression into the open state. The crack tips at the points A, B and C remain in a stable state under this overloading. The crack tips at points D, E and F, however, are in an unstable state under overloading, and the cracks will propagate in the river direction.
